BURNSIDE

2017 Municipal Bridge Inspection Report

**Township of Severn
1024 Hurlwood Lane
P.O. Box 159
Orillia ON L3V 6J3**

**October 18, 2017
300040644.0000**

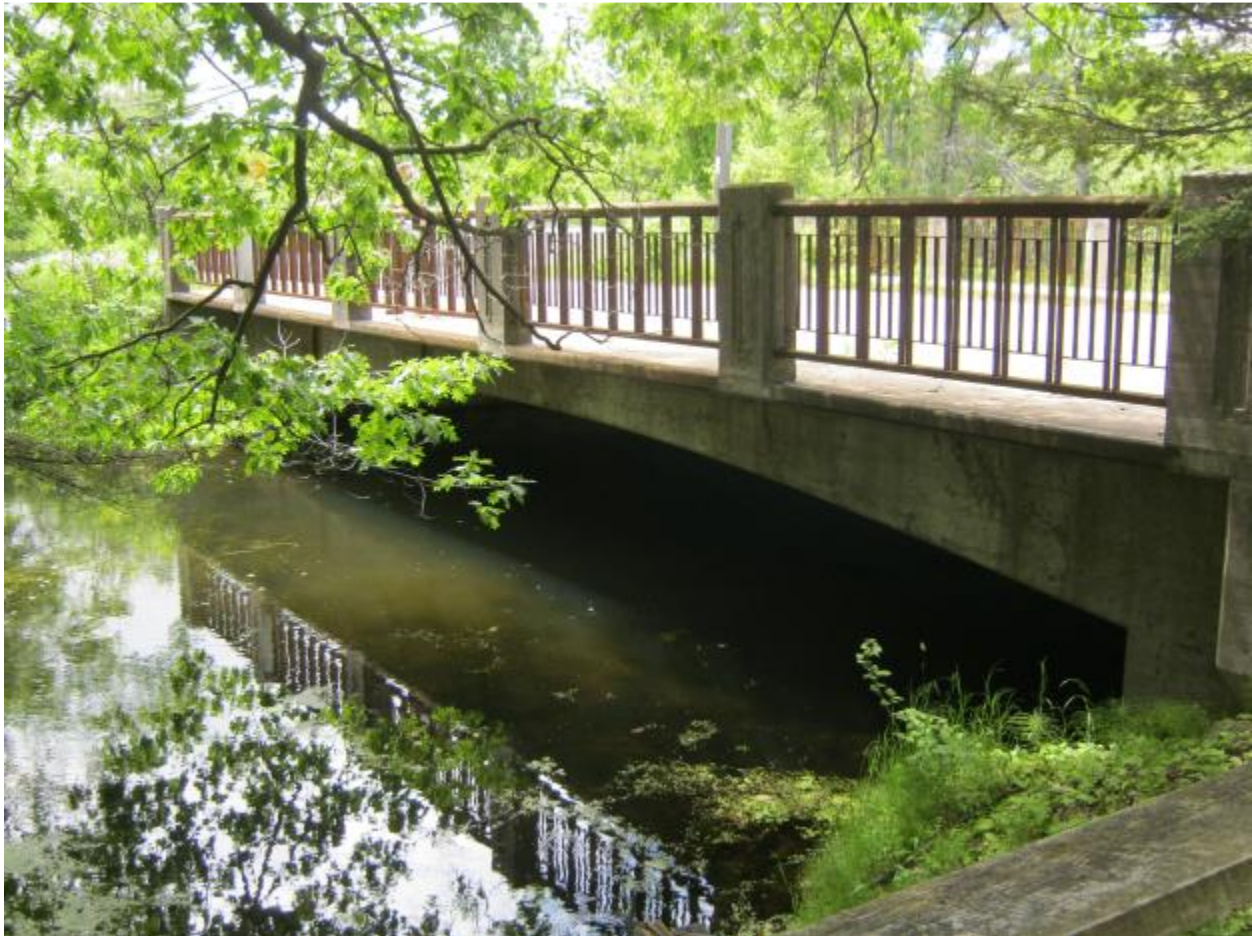
Structure Number	B04
Road Name:	Bond Road
Location:	Lot 9, Conc XIV, Washago, 0.10 km E of Highway 11
Structure Type:	Cast-In-Place Concrete Rigid Frame
Number of Spans:	1
Span Lengths:	14.2 m
Overall Structure Width:	12.1 m
Roadway Width:	9.2 m
Year of Construction:	1960
Current Load Limit:	N/A
2017 Bridge Condition Index	68.1

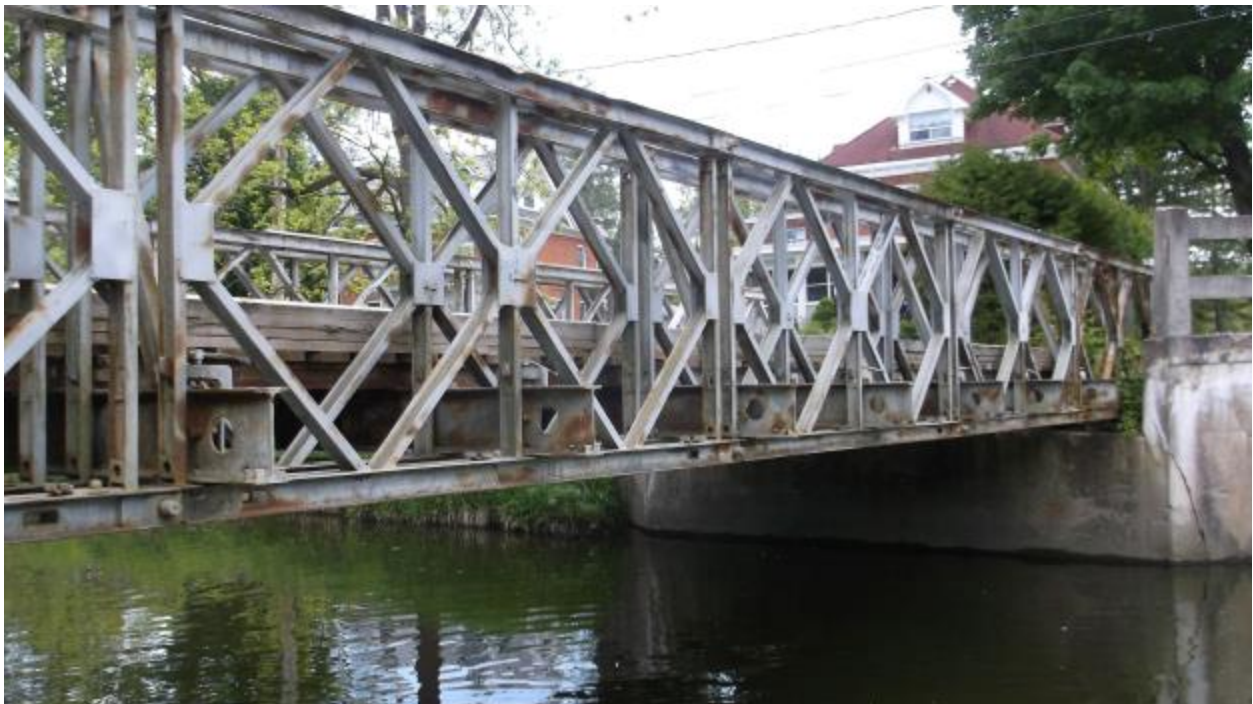
Structure Number	B11
Road Name:	Reinbird Street
Location:	0.01 km W of River Street
Structure Type:	Bailey Bridge
Number of Spans:	1
Span Lengths:	14.6 m
Overall Structure Width:	3.8 m
Roadway Width:	3.55 m
Year of Construction:	1930
Current Load Limit:	N/A
2017 Bridge Condition Index	55.2

Maintenance Need	Element and Comments	Estimated Cost
Timber Repair	Replace curb connections	\$1,000.00
Total		\$1,000.00

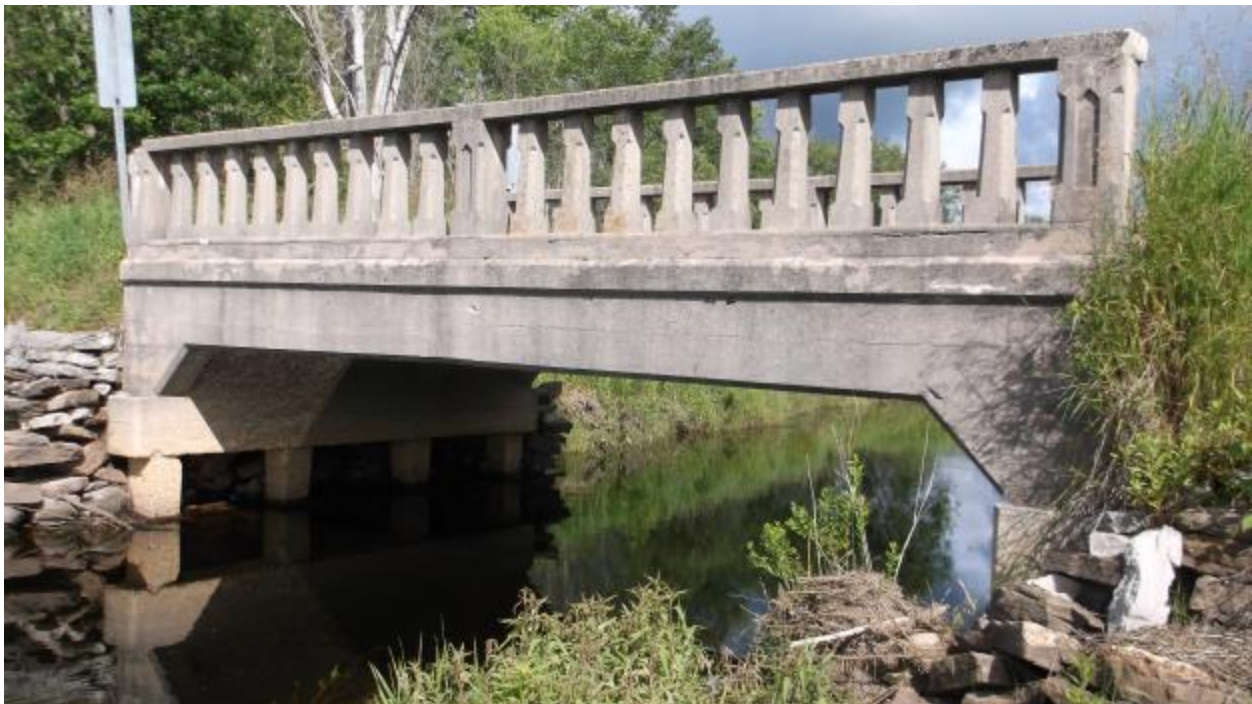
Structure Number	B19
Road Name:	Kitchen Sideroad
Location:	1.4 km E of Church Line North
Structure Type:	CIP Concrete
Number of Spans:	1
Span Lengths:	7.9 m
Overall Structure Width:	4.85 m
Roadway Width:	4.05 m
Year of Construction:	1924
Current Load Limit:	13 tonnes
2017 Bridge Condition Index	50.8

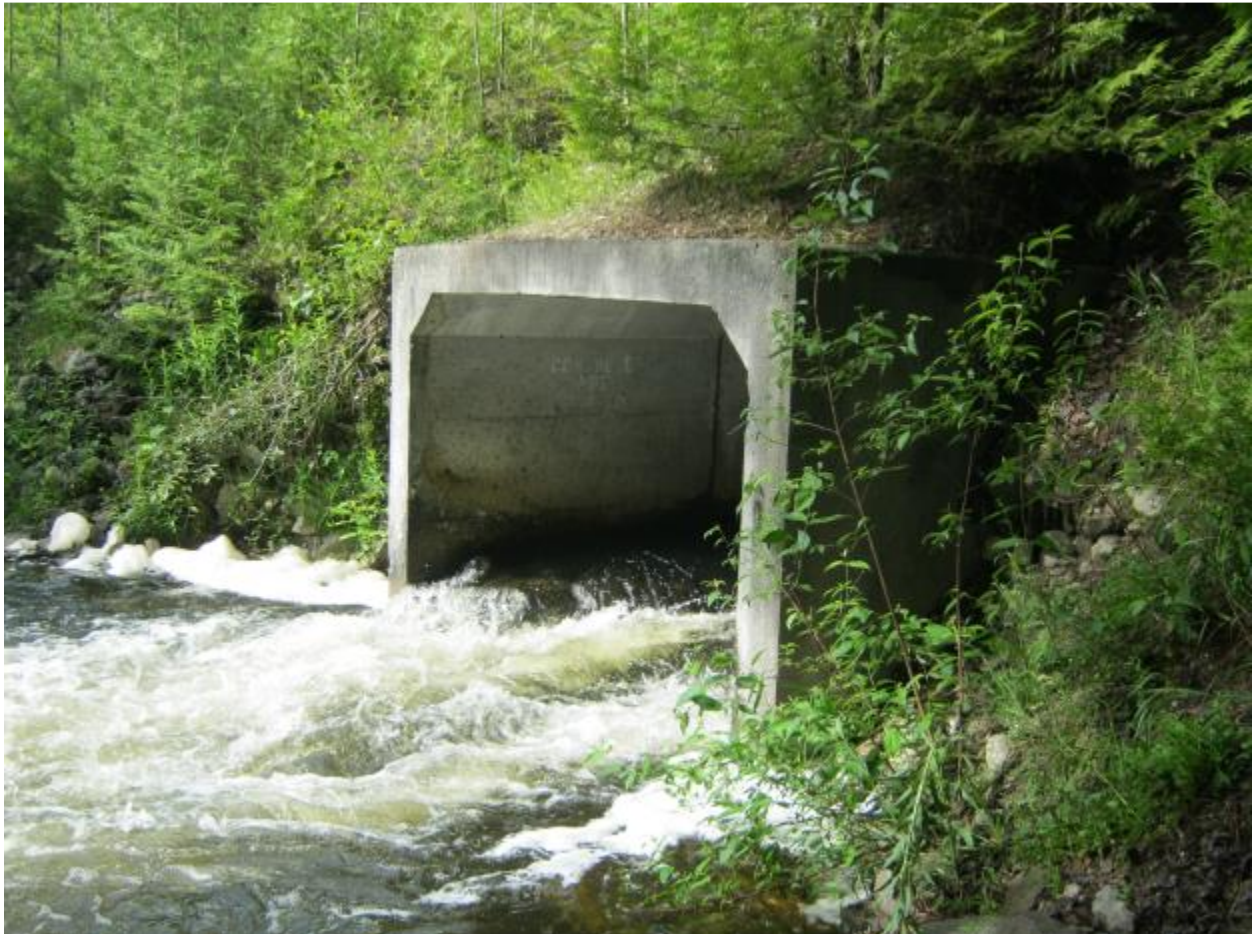
Structure Number	C8
Road Name:	Wainman Line
Location:	Lot 1, Conc III/IV, 0.60 km N of Division Road West
Structure Type:	Cast-In-Place Concrete Rigid Frame
Number of Spans:	1
Span Lengths:	2.8 m
Overall Structure Width:	57 m
Roadway Width:	6.75 m
Year of Construction:	1930
Current Load Limit:	N/A
2017 Bridge Condition Index	49.5

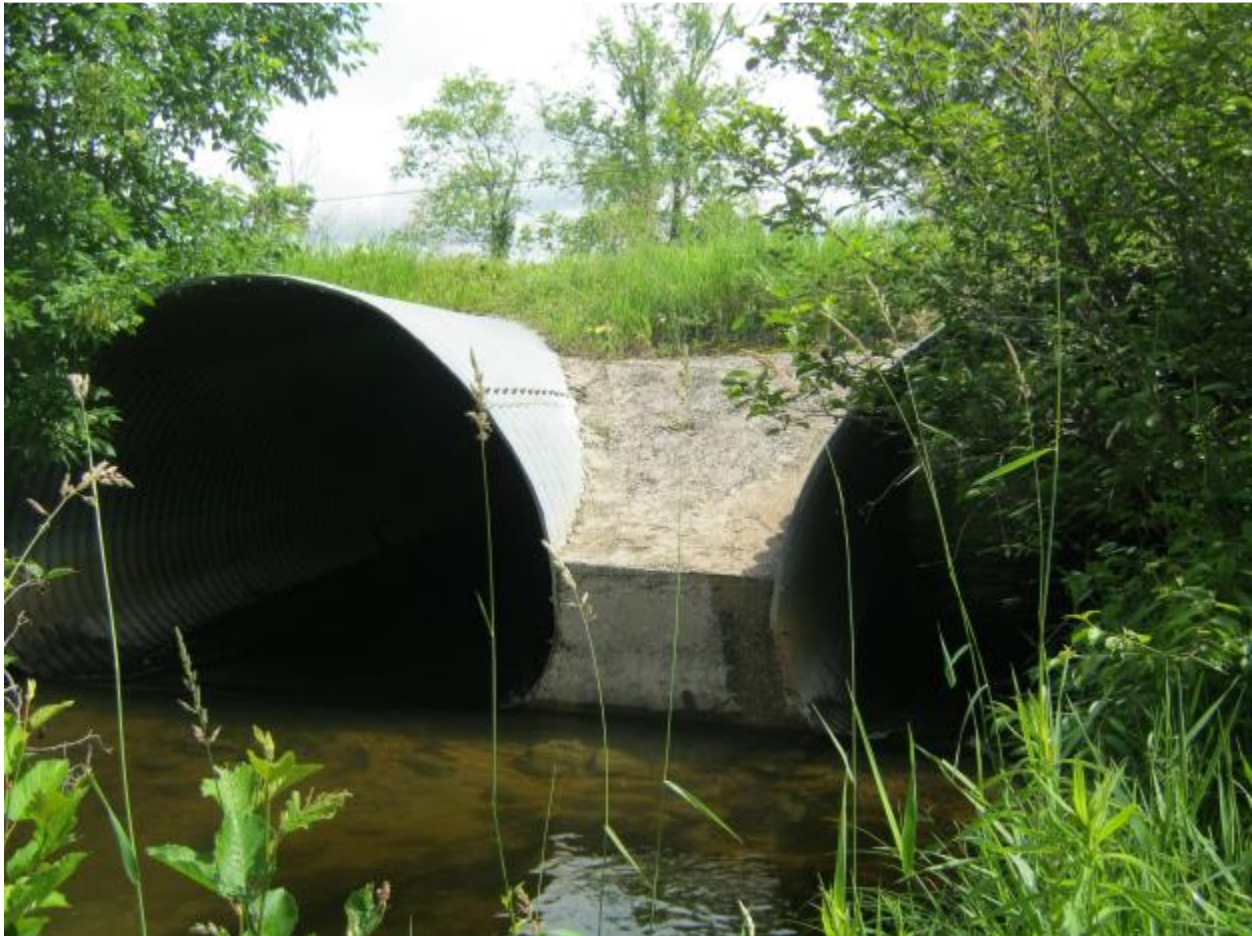
Structure Number	C09
Road Name:	Uhthoff Line
Location:	Lot 2, Conc III/IV, 2.10 km N of Division Road West
Structure Type:	CSP Arch Culvert
Number of Spans:	2
Span Lengths:	3.8, 3.8 m
Overall Structure Width:	18.3 m
Roadway Width:	7.1 m
Year of Construction:	1970
Current Load Limit:	N/A
2017 Bridge Condition Index	38.6

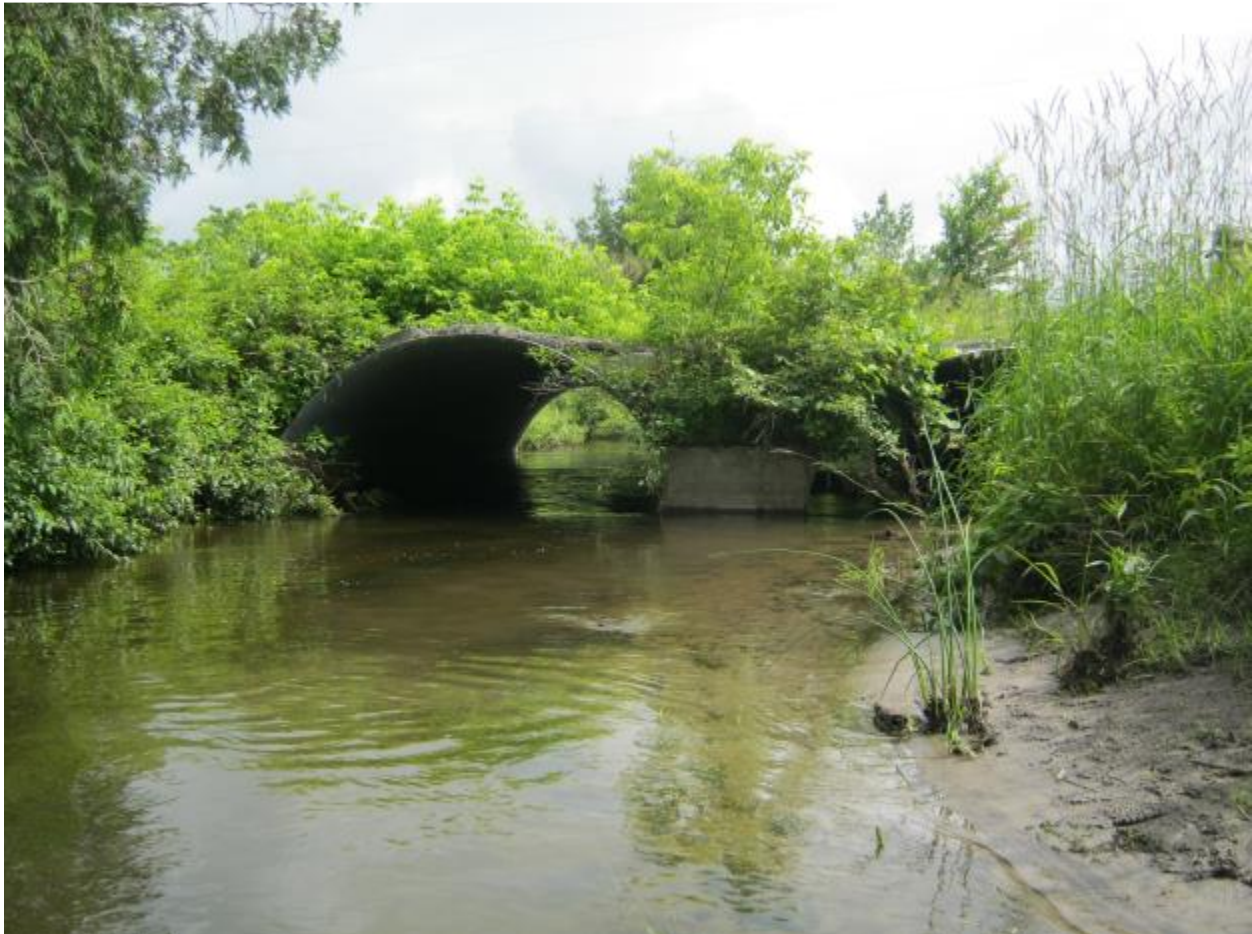
Structure Number	C37
Road Name:	Fairgrounds Road
Location:	Lot 4, Conc II/III, 1.70 km N of Division Road West
Structure Type:	CSP Arch Culvert
Number of Spans:	2
Span Lengths:	3.7, 3.7 m
Overall Structure Width:	17 m
Roadway Width:	6.5 m
Year of Construction:	1970
Current Load Limit:	N/A
2017 Bridge Condition Index	38.1

C-37	Monitoring Crack Widths	Determine if deficiencies are progressing.	\$2,500.00
Total			\$80,000.00
