BURNSIDE

2017 Municipal Bridge Inspection Report

**Township of Severn
1024 Hurlwood Lane
P.O. Box 159
Orillia ON L3V 6J3**

**October 18, 2017
300040644.0000**

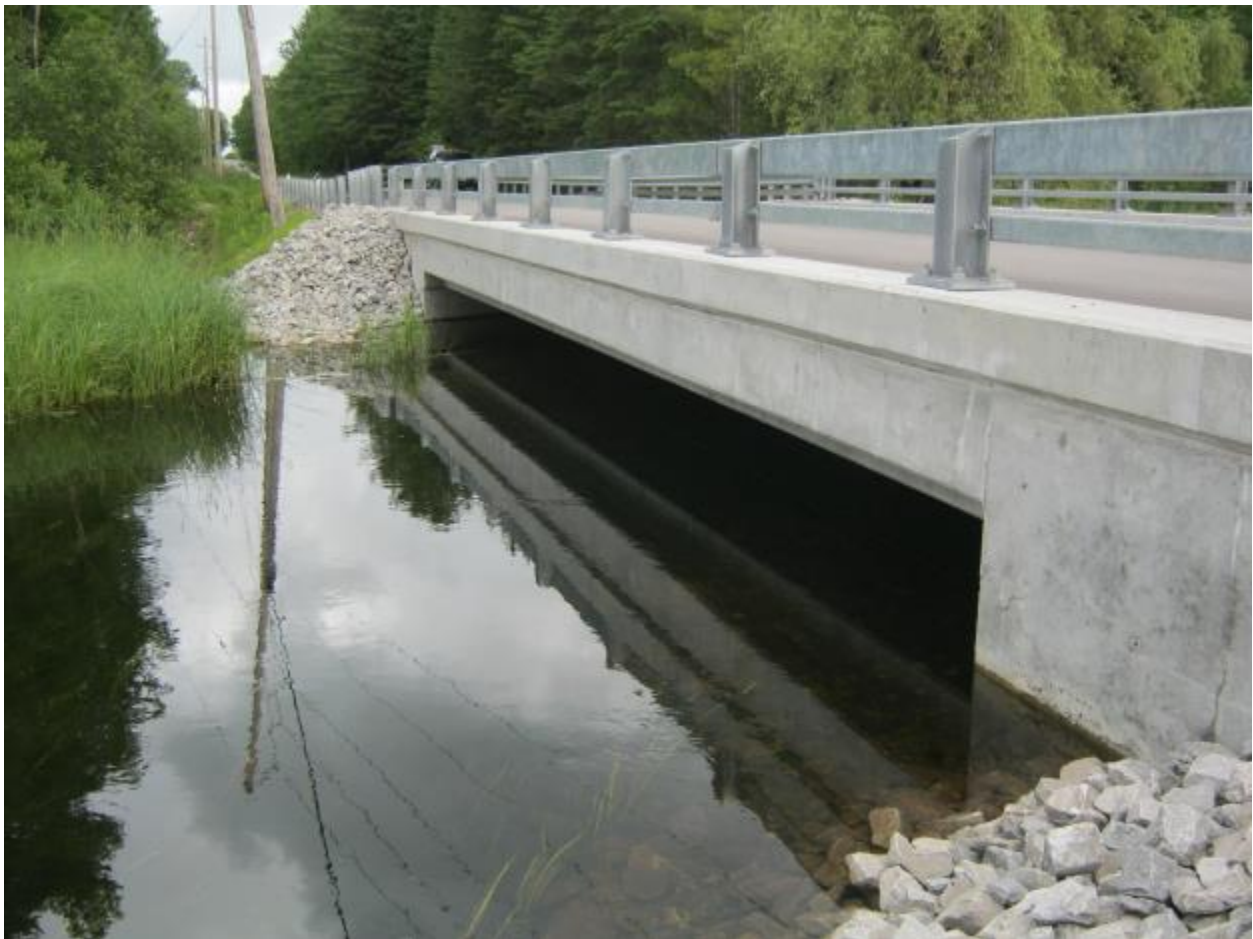
1.1 Bridge No. 3

Structure Number	B03
Road Name:	Townline
Location:	Lot 4 Conc XIV - 1.6km S of Warminster
Structure Type:	Prestressed Hollowcore Slab
Number of Spans:	1
Span Lengths:	12 m
Overall Structure Width:	10 m
Roadway Width:	9 m
Year of Construction:	2016
Current Load Limit:	N/A
2017 Bridge Condition Index	99.9

Maintenance Need	Element and Comments	Estimated Cost
Handrail Maintenance	Install missing bolts / tighten bolts in handrail	\$0.00
Bridge Cleaning	Routine deck sweeping	\$1,000.00
Total		\$1,000.00

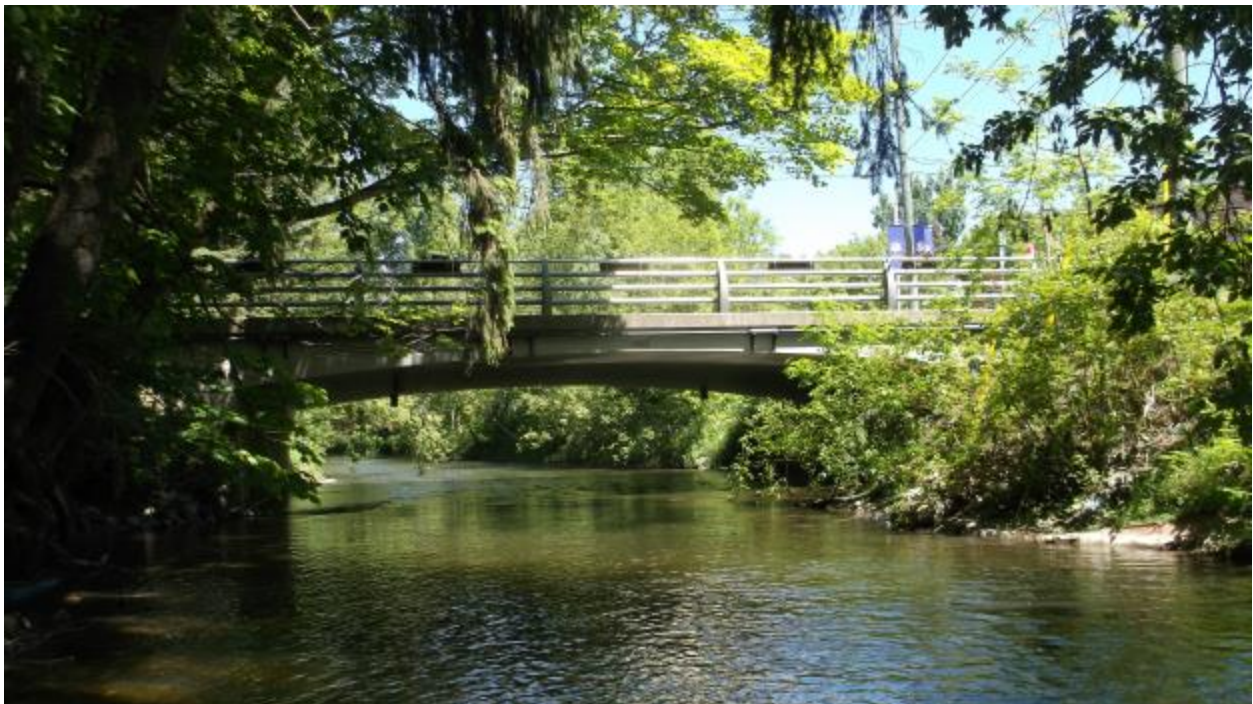
1.3 Bridge No. 5 (The Rick Hansen Bridge)

Structure Number	B05
Road Name:	Sturgeon Bay Road
Location:	0.03 km W of Coldwater Road, Coldwater
Structure Type:	TS - Cast-In-Place Concrete Rigid Frame
Number of Spans:	1
Span Lengths:	15.2 m
Overall Structure Width:	14.2 m
Roadway Width:	10.4 m
Year of Construction:	1982
Current Load Limit:	N/A
2017 Bridge Condition Index	74.2

Maintenance Need	Element and Comments	Estimated Cost
Handrail Maintenance	Replace missing end caps on handrail	\$500.00
Rout and Seal	Rout and seal cracks in asphalt	\$1,000.00
Deck Drainage	Flush deck drains	\$500.00
Hazard Signs	Install hazard warning signs at structure	\$1,000.00
Total		\$3,000.00

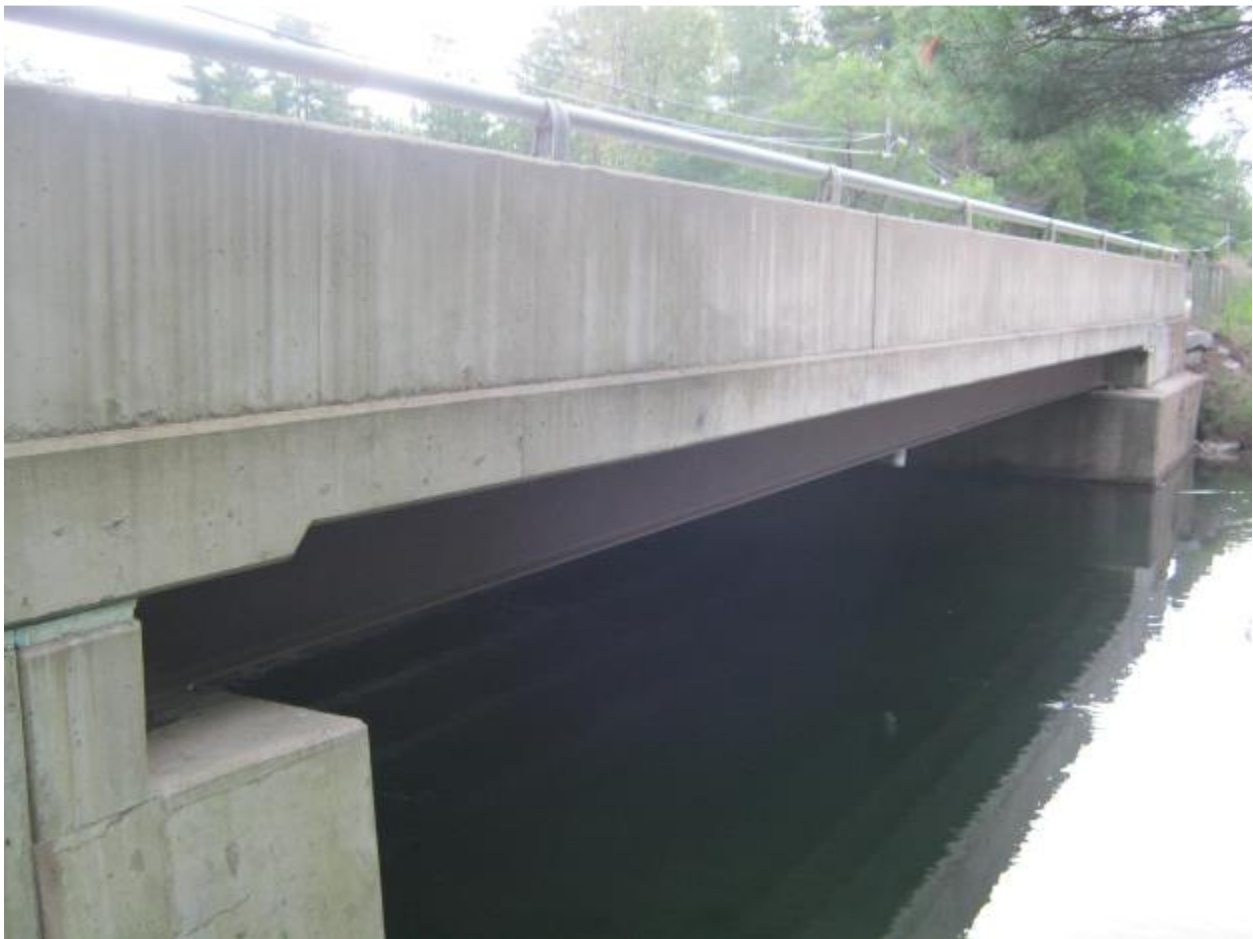
1.4 Bridge No. 6

Structure Number	B06
Road Name:	Muskoka Street
Location:	Lot 11, Conc XV, Washago, 0.10 km S of Coopers Falls Road
Structure Type:	Steel Girder with Concrete Deck
Number of Spans:	1
Span Lengths:	18 m
Overall Structure Width:	9.4 m
Roadway Width:	8.4 m
Year of Construction:	2000
Current Load Limit:	N/A
2017 Bridge Condition Index	74

Maintenance Need	Element and Comments	Estimated Cost
Bridge Cleaning	Clean Deck Wearing Surface	\$1,000.00
Rout and Seal	Repairs required to Deck Wearing Surface	\$1,000.00
Total		\$2,000.00

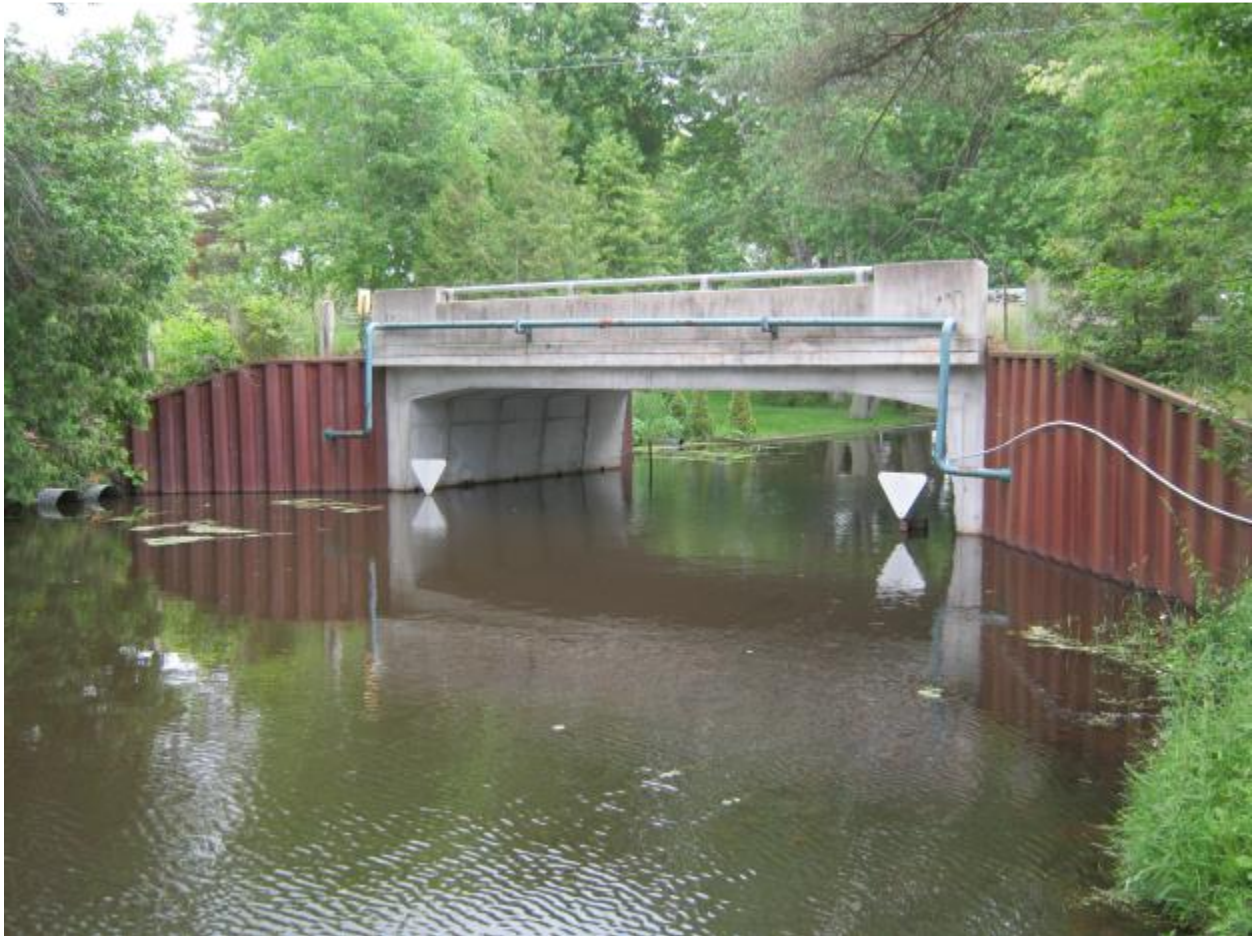
1.5 Bridge No. 7

Structure Number	B07
Road Name:	Bayou Road
Location:	Lot 3, Conc IX, 0,10 km N of Westchore Cres
Structure Type:	Precast Concrete Rigid Frame
Number of Spans:	1
Span Lengths:	10 m
Overall Structure Width:	6.9 m
Roadway Width:	4.7 m
Year of Construction:	1990
Current Load Limit:	N/A
2017 Bridge Condition Index	74.6

Maintenance Need	Element and Comments	Estimated Cost
Handrail Maintenance	Replace missing end cap on handrail	\$500.00
Erosion Control	Repairs required to Embankments,	\$2,500.00
Hazard Signs	Install hazard warning signs at structure	\$1,000.00
Total		\$4,000.00

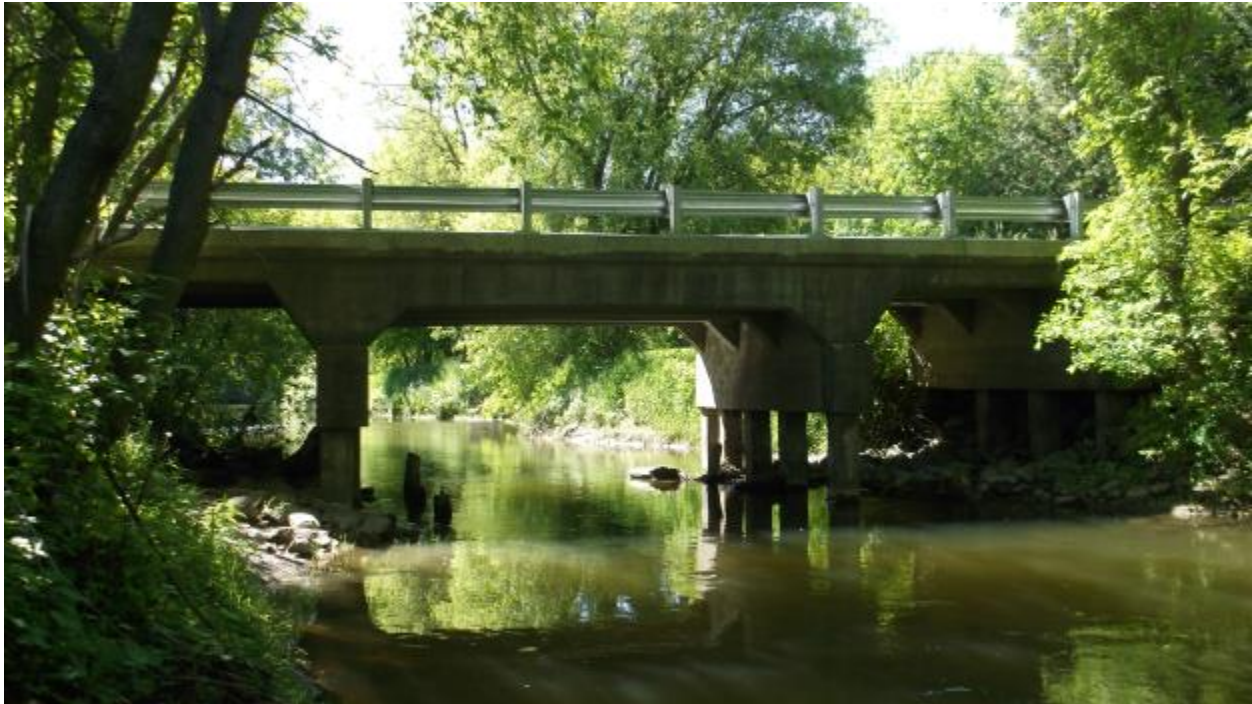
1.6 Bridge No. 10

Structure Number	B10
Road Name:	Woodrow Road
Location:	Lots 20/21, Conc XI, 0.20 km W of Highway 12
Structure Type:	Cast-In-Place Concrete T-Beam
Number of Spans:	3
Span Lengths:	3.75, 6.4, 3.75 m
Overall Structure Width:	5.6 m
Roadway Width:	4.6 m
Year of Construction:	1930
Current Load Limit:	N/A
2017 Bridge Condition Index	70.7

Maintenance Need	Element and Comments	Estimated Cost
Rout and Seal	Repairs required to Deck Wearing Surface	\$500.00
Other	Remove debris from watercourse	\$1,000.00
Total		\$1,500.00

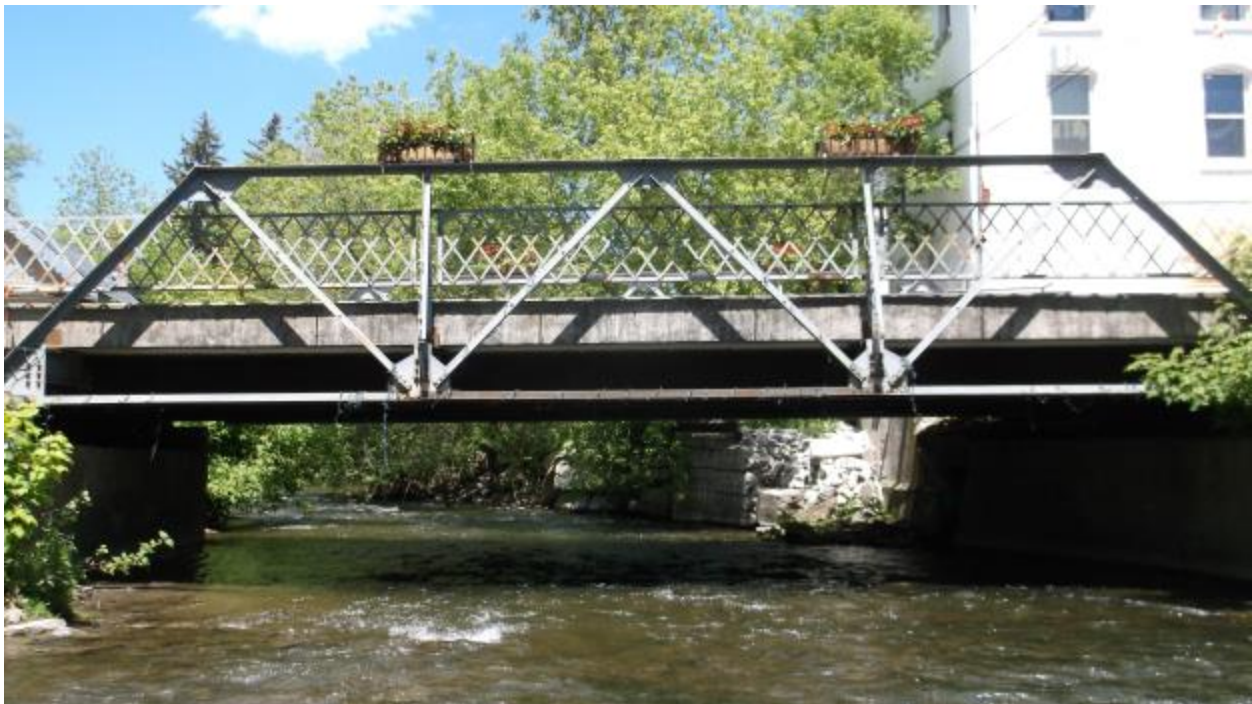
1.8 Bridge No. 12

Structure Number	B12
Road Name:	Mill Street, Coldwater
Location:	0.02 km W of Coldwater Road
Structure Type:	Concrete Deck on Steel Truss
Number of Spans:	1
Span Lengths:	19.5 m
Overall Structure Width:	6.7 m
Roadway Width:	4.9 m
Year of Construction:	1980
Current Load Limit:	N/A
2017 Bridge Condition Index	73.9

Maintenance Need	Element and Comments	Estimated Cost
Bridge Cleaning	Clean Deck Wearing Surface	\$1,000.00
Total		\$1,000.00

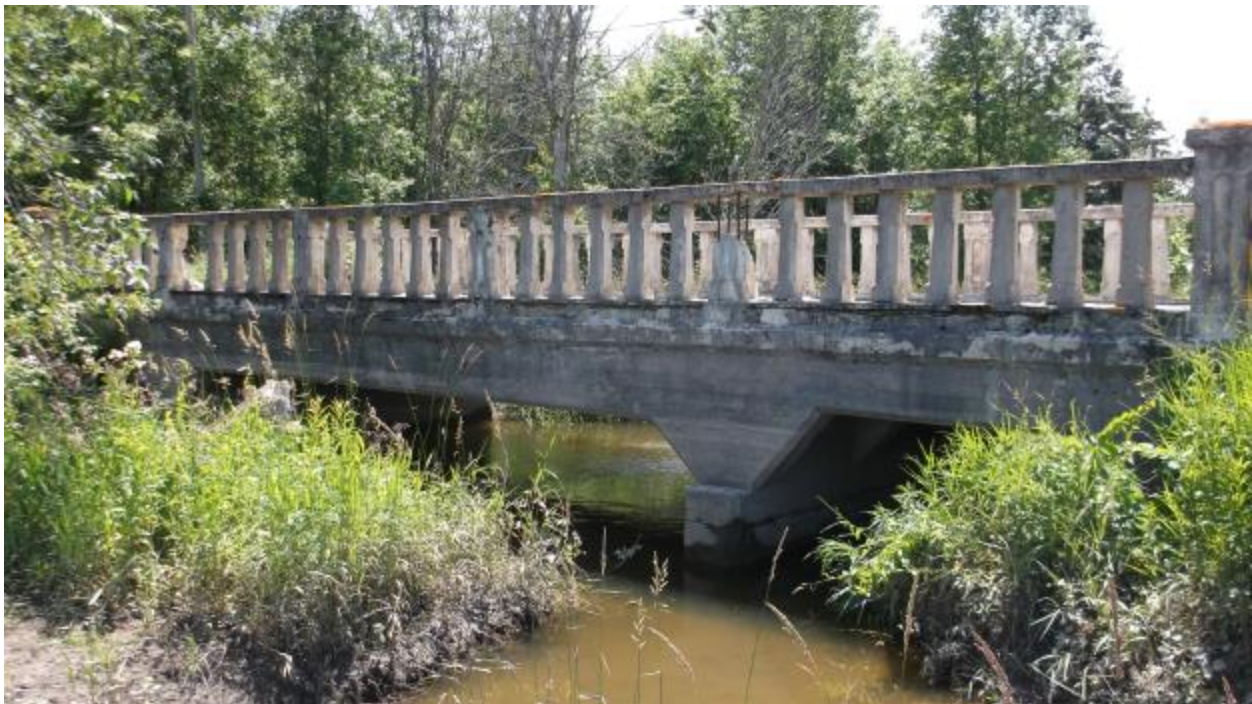
1.9 Bridge No. 13

Structure Number	B13
Road Name:	Hampshire Mills Line
Location:	2.3 km N of Cambrian Road
Structure Type:	CIP Concrete on T-Beam
Number of Spans:	3
Span Lengths:	2.9, 7.6, 2.9 m
Overall Structure Width:	4.9 m
Roadway Width:	4.2 m
Year of Construction:	1930
Current Load Limit:	14 tonnes
2017 Bridge Condition Index	66.2

Maintenance Need	Element and Comments	Estimated Cost
Bridge Cleaning	Clean Deck Wearing Surface	\$1,000.00
Total		\$1,000.00

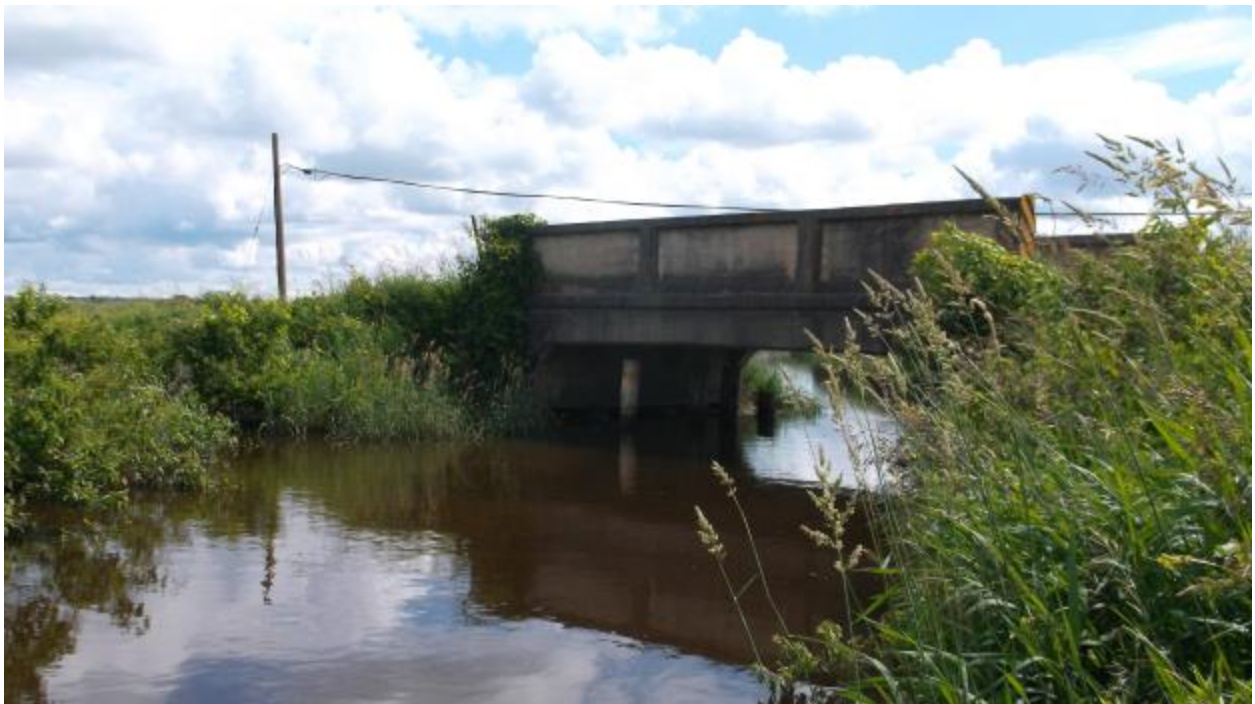
1.10 Bridge No. 14

Structure Number	B14
Road Name:	Uhthoff Line
Location:	0.4 km S of Foxmead Road
Structure Type:	CIP Concrete
Number of Spans:	1
Span Lengths:	7.6 m
Overall Structure Width:	5.5 m
Roadway Width:	4.7 m
Year of Construction:	1940
Current Load Limit:	N/A
2017 Bridge Condition Index	64.4

Maintenance Need	Element and Comments	Estimated Cost
Bridge Cleaning	Clean Deck Top	\$1,000.00
Hazard Signs	Mount hazard warning signs on posts	\$500.00
Total		\$1,500.00

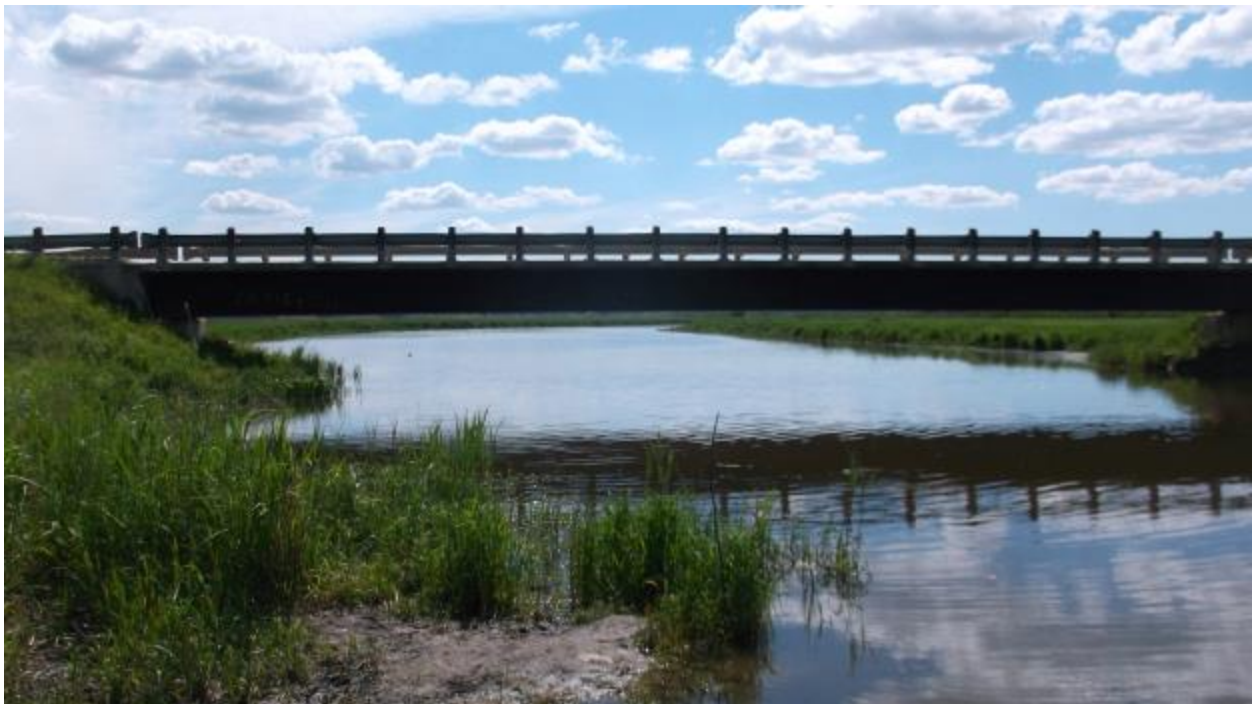
1.11 Bridge No. 15

Structure Number	B15
Road Name:	Lawson Line
Location:	1.5 km S of Kinnear Sideroad
Structure Type:	CIP Concrete on Steel Girder
Number of Spans:	1
Span Lengths:	34.5 m
Overall Structure Width:	6.2 m
Roadway Width:	5.1 m
Year of Construction:	1980
Current Load Limit:	N/A
2017 Bridge Condition Index	74

Maintenance Need	Element and Comments	Estimated Cost
Bridge Cleaning	Routine sweeping of Deck Top	\$1,000.00
Total		\$1,000.00

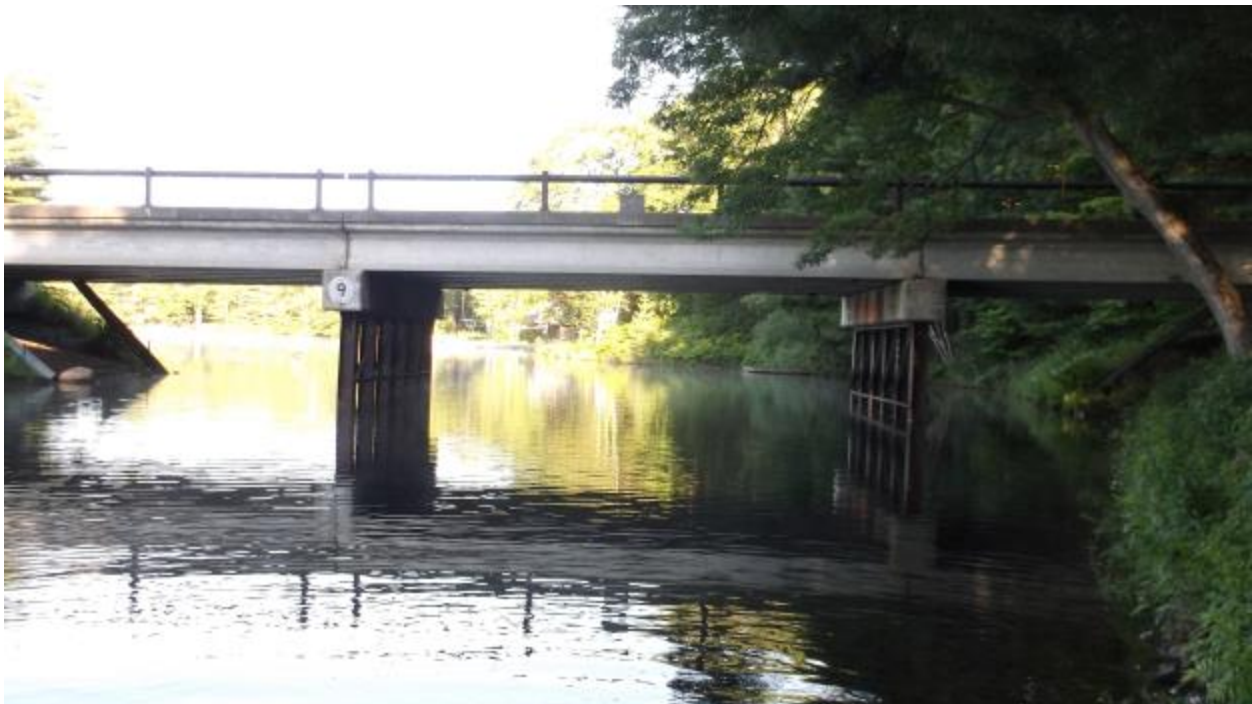
1.12 Bridge No. 16 - Black River Bridge

Structure Number	B16
Road Name:	Irish Line
Location:	0.1 km S of Ellis Road
Structure Type:	Precast Concrete CPCI Girder
Number of Spans:	3
Span Lengths:	12.8,13.1, 12.8 m
Overall Structure Width:	10.3 m
Roadway Width:	8.5 m
Year of Construction:	1961
Current Load Limit:	N/A
2017 Bridge Condition Index	70.4

Maintenance Need	Element and Comments	Estimated Cost
Bridge Cleaning	Clean Deck Wearing Surface	\$1,000.00
Deck Drainage	Flush deck drains	\$1,000.00
Total		\$2,000.00

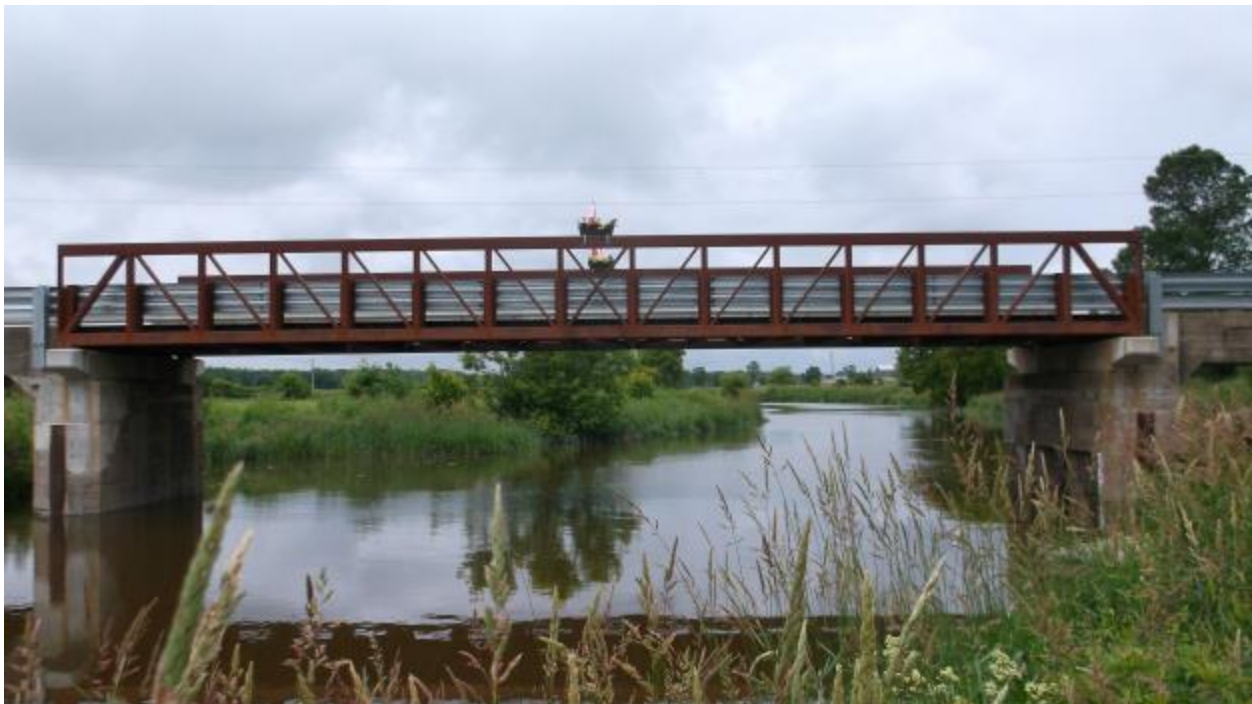
1.13 Bridge No. 17

Structure Number	B17
Road Name:	Lovering Line
Location:	0.1 km S of Upper Big Chute Road
Structure Type:	Steel Through Truss / T-Beams
Number of Spans:	3
Span Lengths:	4.4, 18.3, 4.4 m
Overall Structure Width:	4.8 m
Roadway Width:	4.3 m
Year of Construction:	1930
Current Load Limit:	N/A
2017 Bridge Condition Index	71.8

Maintenance Need	Element and Comments	Estimated Cost
Other	Reverse lap direction of guide rail panels on west	\$2,500.00
Total		\$2,500.00

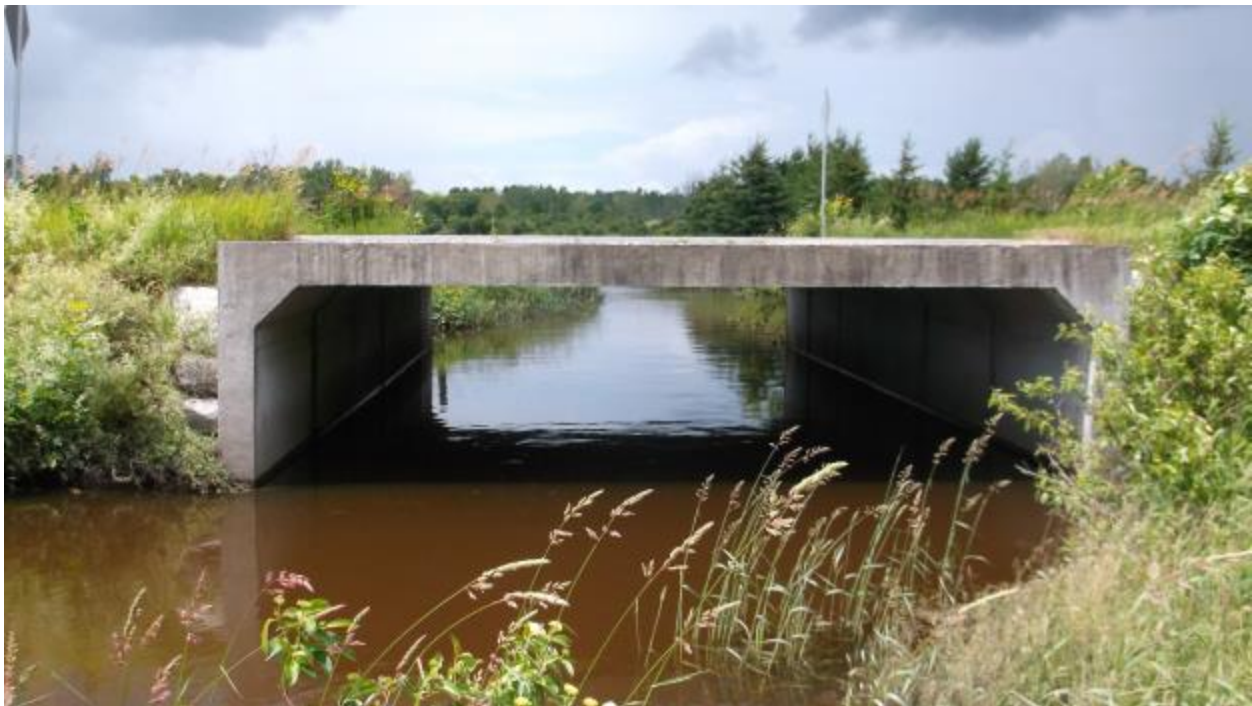
1.16 Bridge No. 21

Structure Number	B21
Road Name:	Foxmead Road
Location:	0.2 km E of Uhthoff Line
Structure Type:	Precast Concrete Box
Number of Spans:	1
Span Lengths:	6.2 m
Overall Structure Width:	12.1 m
Roadway Width:	7 m
Year of Construction:	2000
Current Load Limit:	N/A
2017 Bridge Condition Index	73.1

Maintenance Need	Element and Comments	Estimated Cost
Hazard Signs	Install hazard warning signs at structure	\$1,000.00
Total		\$1,000.00

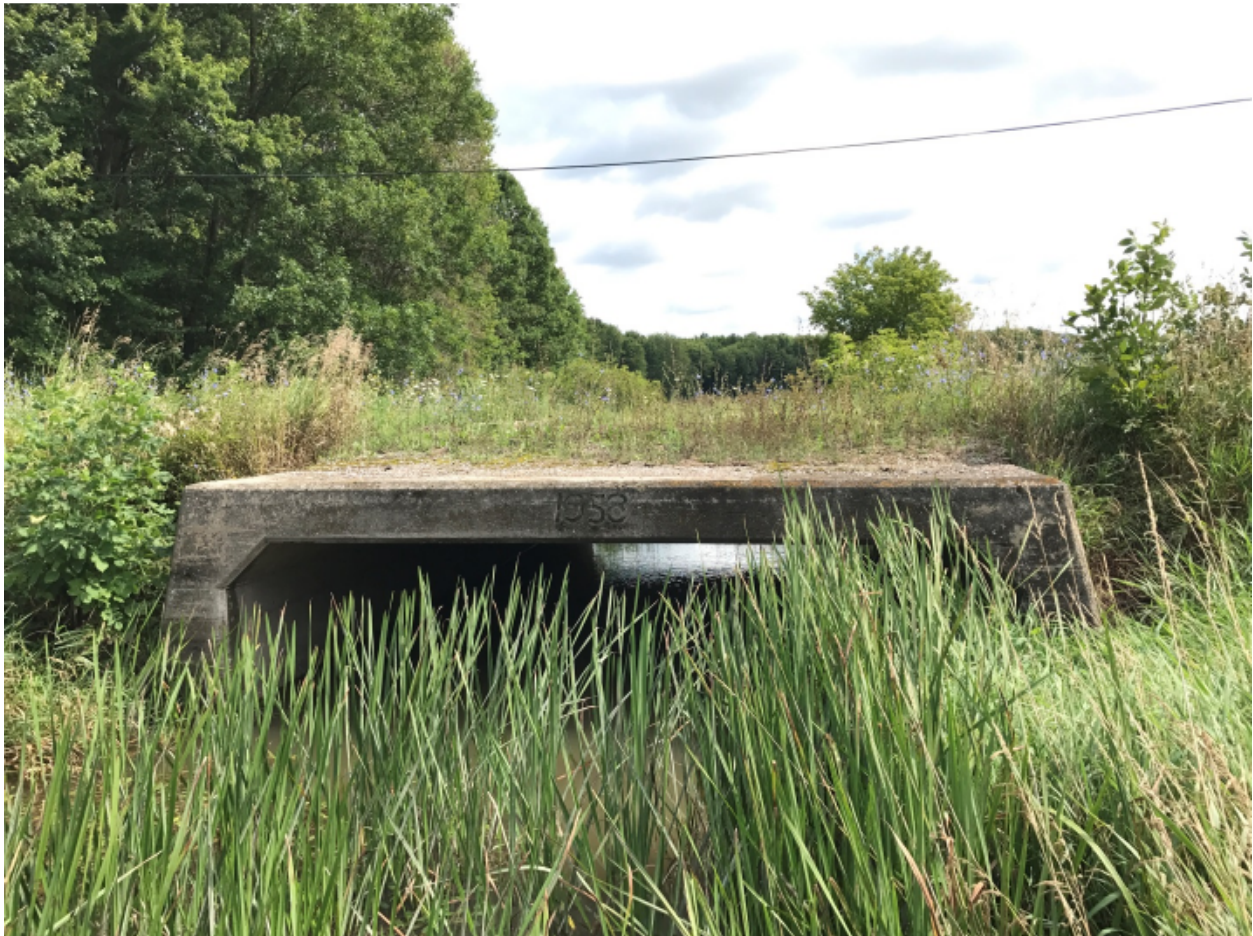
1.17 Bridge No. 22

Structure Number	B22
Road Name:	Burnside Line
Location:	1.95 km S of Jeremy Road
Structure Type:	Open Footing CIP Concrete Box
Number of Spans:	1
Span Lengths:	4.9 m
Overall Structure Width:	12.1 m
Roadway Width:	6.7 m
Year of Construction:	1958
Current Load Limit:	N/A
2017 Bridge Condition Index	73.9

Maintenance Need	Element and Comments	Estimated Cost
Hazard Signs	Install hazard warning signs at structure	\$1,000.00
Total		\$1,000.00

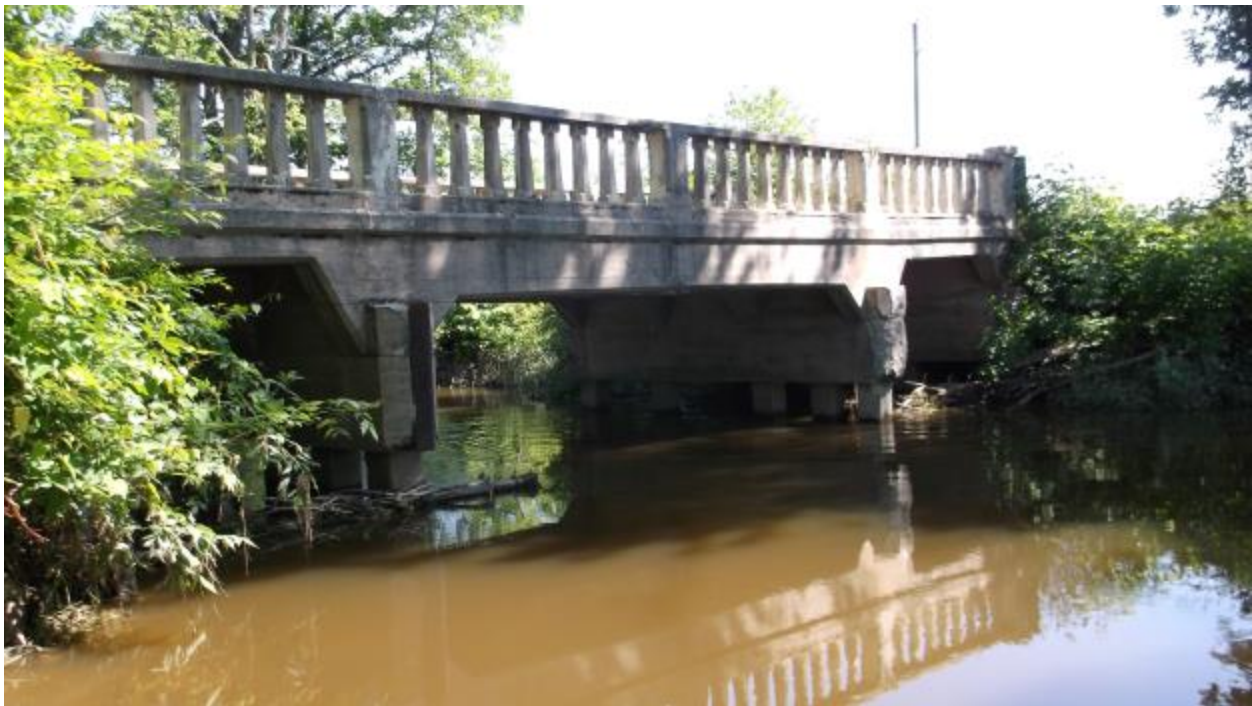
1.18 Bridge No. 23

Structure Number	B23
Road Name:	Jeremy Road
Location:	0.2 km W of Carlyon Line
Structure Type:	CIP Concrete T-Beam
Number of Spans:	3
Span Lengths:	3.15, 6.9, 3.05 m
Overall Structure Width:	5.6 m
Roadway Width:	4.6 m
Year of Construction:	1930
Current Load Limit:	N/A
2017 Bridge Condition Index	59.3

Maintenance Need	Element and Comments	Estimated Cost
Bridge Cleaning	Clean Deck Top, Deck Drainage,	\$2,000.00
Total		\$2,000.00

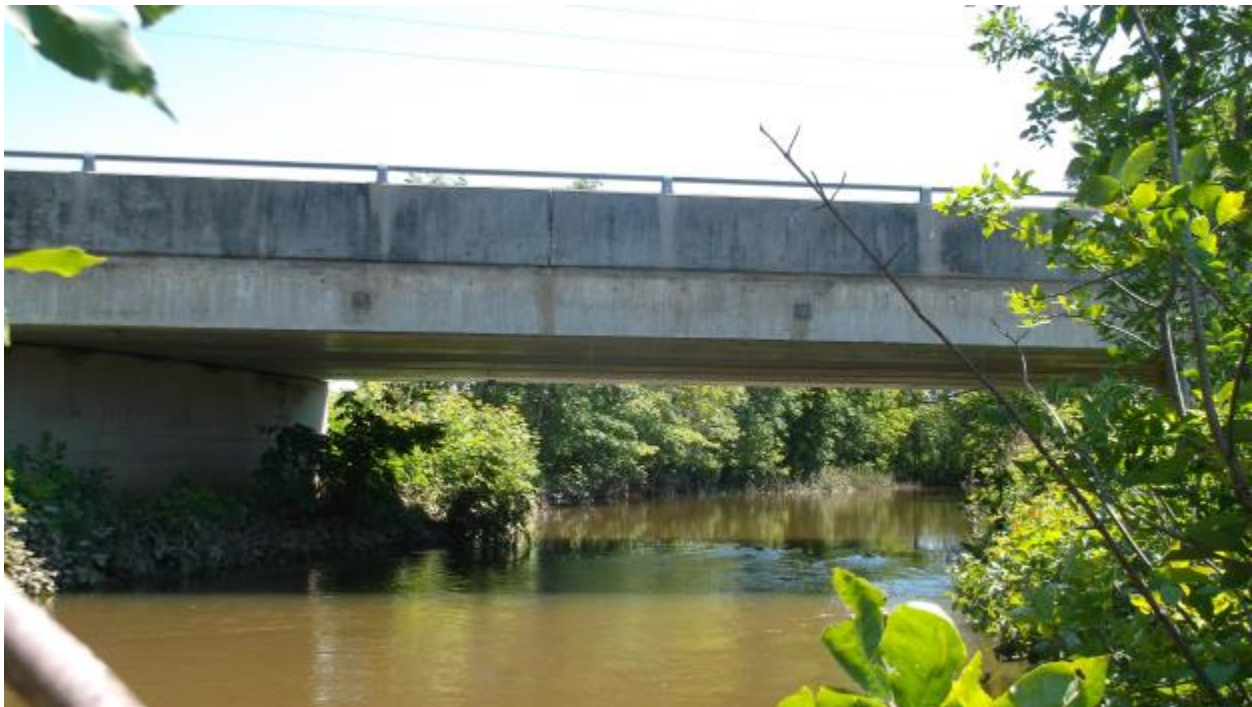
1.19 Bridge No. 24

Structure Number	B24
Road Name:	Carlyon Line
Location:	Lot 19, Conc V/VI, 2.10 km N of Maple Valley Road
Structure Type:	Precast Concrete Box Girder
Number of Spans:	1
Span Lengths:	16.4 m
Overall Structure Width:	8.9 m
Roadway Width:	7.9 m
Year of Construction:	1980
Current Load Limit:	N/A
2017 Bridge Condition Index	72.8

Maintenance Need	Element and Comments	Estimated Cost
Bridge Cleaning	Clean Deck Wearing Surface, Deck Drainage	\$1,000.00
Total		\$1,000.00

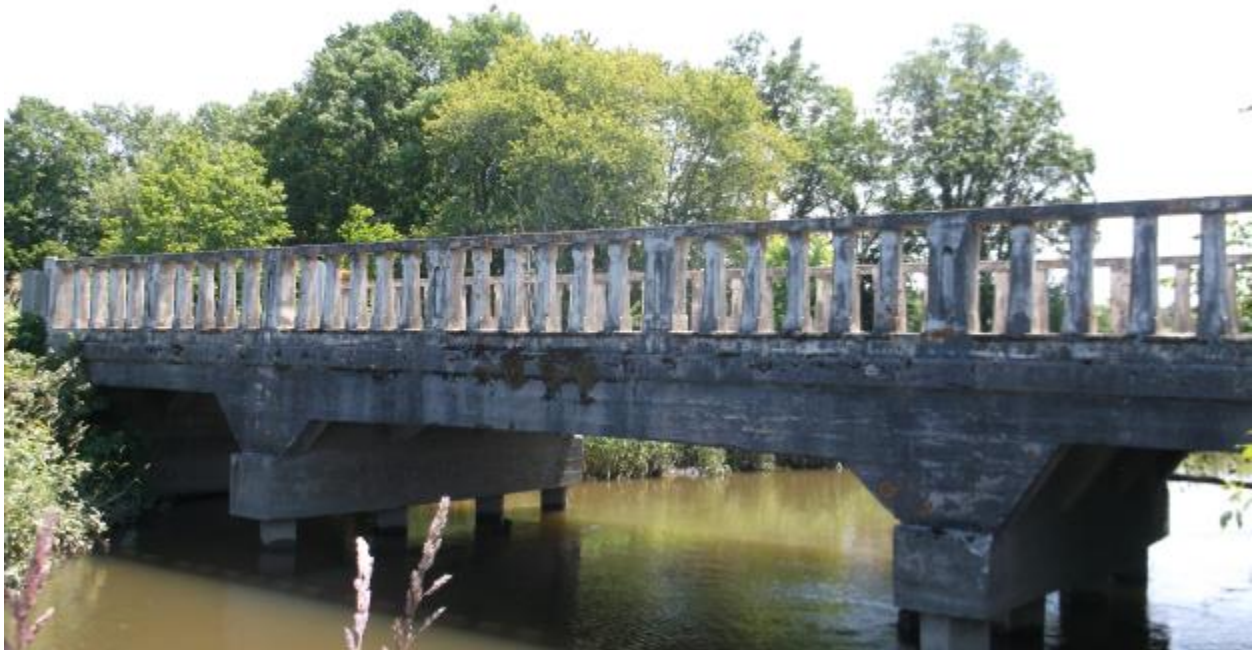
1.22 Bridge No. 27

Structure Number	B27
Road Name:	Maple Valley Road
Location:	Lot 15/16, Conc VI, 0.30 km W of Hampshire Mills Line
Structure Type:	Cast-In-Place Concrete T-Beam
Number of Spans:	3
Span Lengths:	3.85, 6.9, 3.65 m
Overall Structure Width:	4.9 m
Roadway Width:	4.1 m
Year of Construction:	1930
Current Load Limit:	14 tonnes
2017 Bridge Condition Index	63

Maintenance Need	Element and Comments	Estimated Cost
Bridge Cleaning	Clean Deck Top	\$1,000.00
Total		\$1,000.00

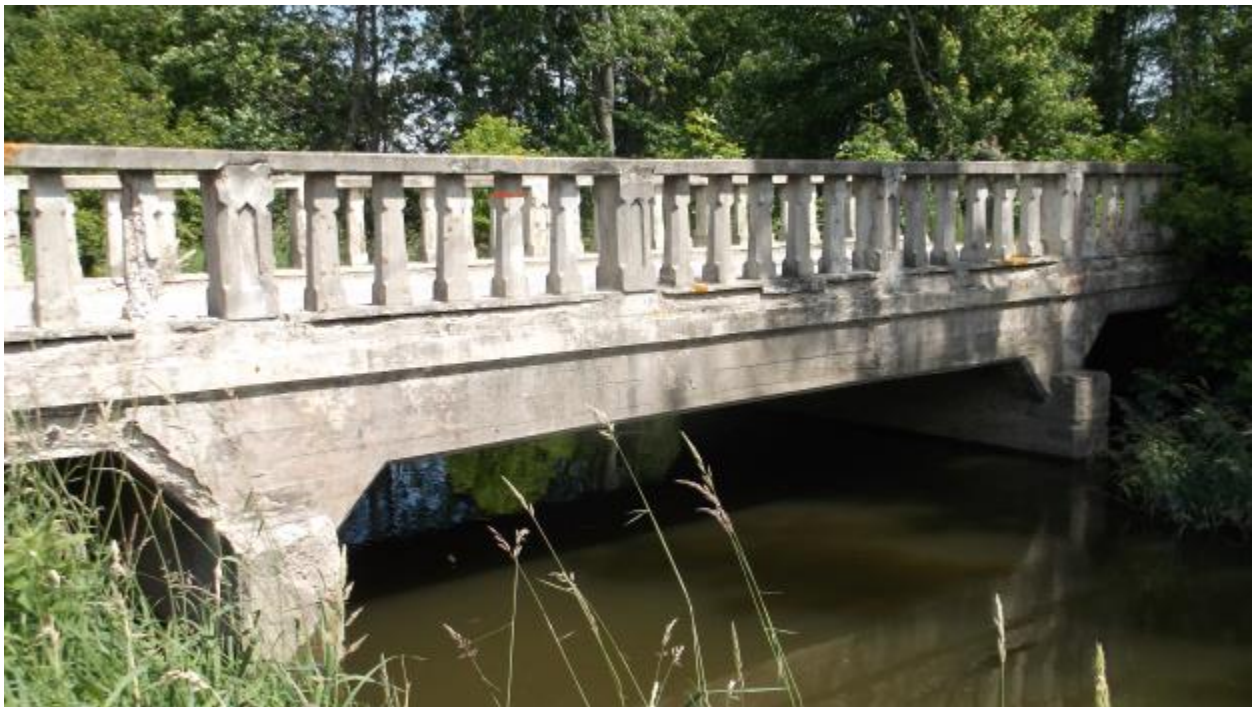
1.23 Bridge No. 28

Structure Number	B28
Road Name:	Hampshire Mills Line
Location:	Lot 14, Conc VI/VII, 1.80 km N of Cambrian Road
Structure Type:	Cast-In-Place Concrete T-Beam
Number of Spans:	3
Span Lengths:	3.45, 7.45 m
Overall Structure Width:	4.9 m
Roadway Width:	4.1 m
Year of Construction:	1930
Current Load Limit:	14 tonnes
2017 Bridge Condition Index	54.2

Maintenance Need	Element and Comments	Estimated Cost
Bridge Cleaning	Clean Deck Wearing Surface	\$1,000.00
Hazard Signs	Mount hazard signs on posts at required height and distance from structure end	\$500.00
Total		\$1,500.00

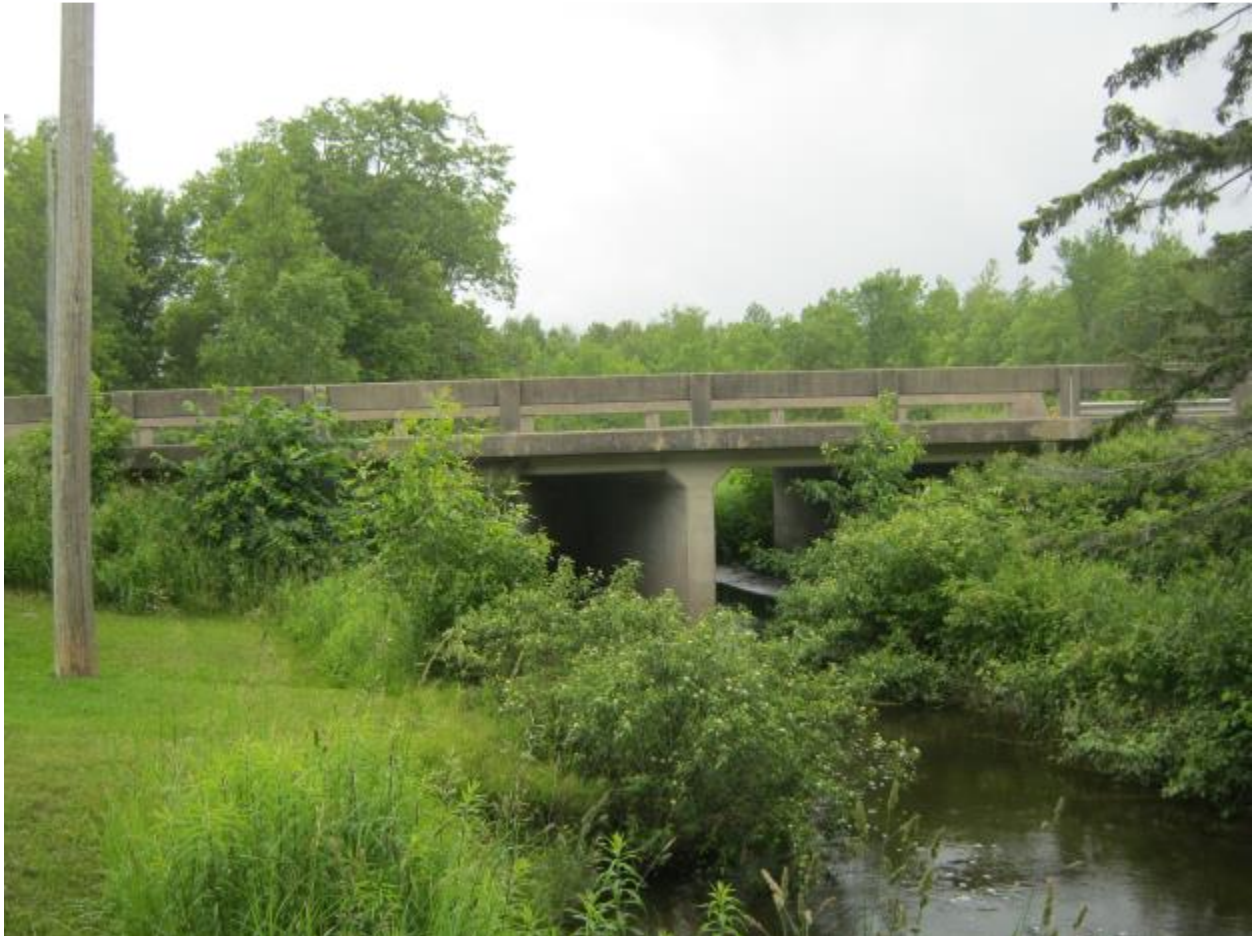
1.25 Bridge No. 32 (North River Bridge)

Structure Number	B32
Road Name:	Burnside Line
Location:	Lot 4, Conc IV/V, 0.40 km S of Warminster Road
Structure Type:	Cast-In-Place Concrete Open Footing
Number of Spans:	2
Span Lengths:	5.2, 5.2 m
Overall Structure Width:	11.1 m
Roadway Width:	9.2 m
Year of Construction:	1965
Current Load Limit:	N/A
2017 Bridge Condition Index	73.6

Maintenance Need	Element and Comments	Estimated Cost
Bridge Cleaning	Clean Approach Wearing Surface, Deck Wearing Surface	\$1,000.00
Rout and Seal	Repairs required to Approach Wearing Surface, Deck Wearing Surface	\$1,500.00
Hazard Signs	Install hazard warning signs at structure	\$1,000.00
Other	Replace sealant in barrier/sidewalk joints	\$3,000.00
Total		\$6,500.00

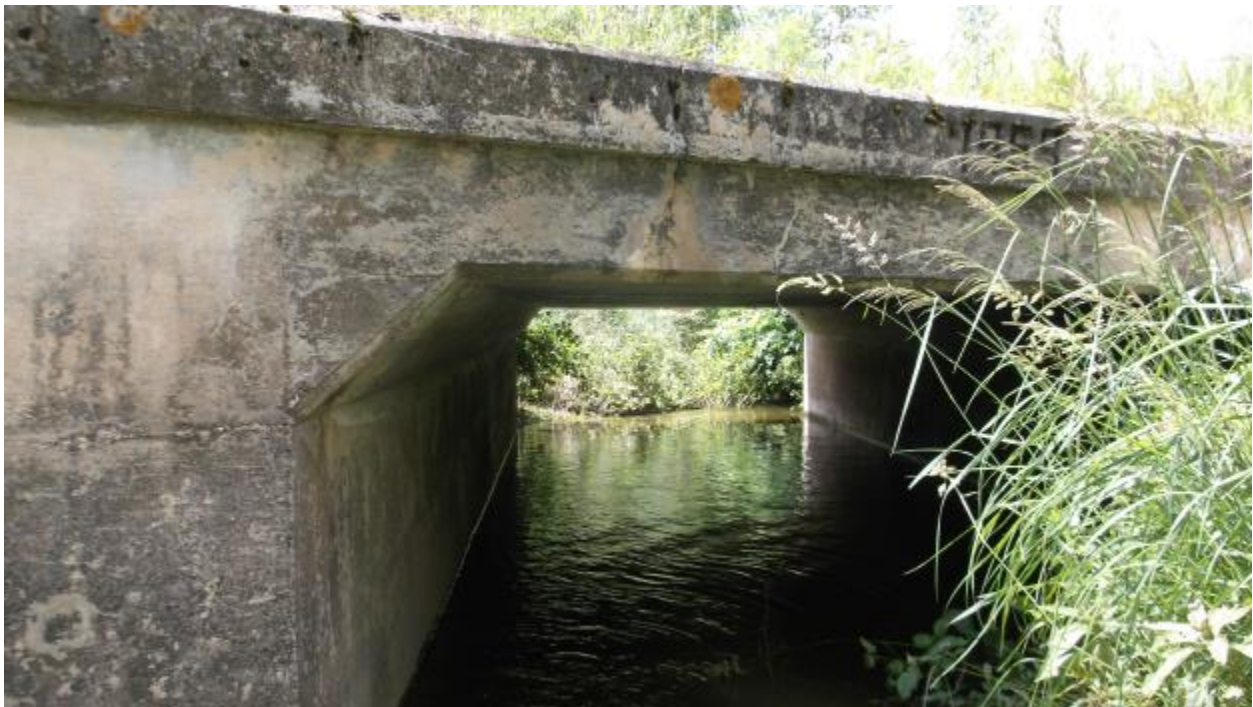
1.26 Bridge No. 34

Bridge 34 is generally in good condition with only minor deficiencies noted and no repairs required at this time. Based on the current BCI of 74.8 and the span of 4.8m (less than 6m), a rehabilitation is not recommended and replacement of the structure is recommended once the BCI reaches 40, in approximately 17 years at a cost of approximately \$450,000. In the interim, consideration should be given to completing the recommended maintenance work and installing a steel beam guide rail system with end treatments to help protect oncoming traffic.

Maintenance Need	Element and Comments	Estimated Cost
Bridge Cleaning	Trim vegetation on shoulders - hazard signs not clearly visible	\$250.00
Rout and Seal	Repairs required to Approach Wearing Surface	\$500.00
Total		\$750.00

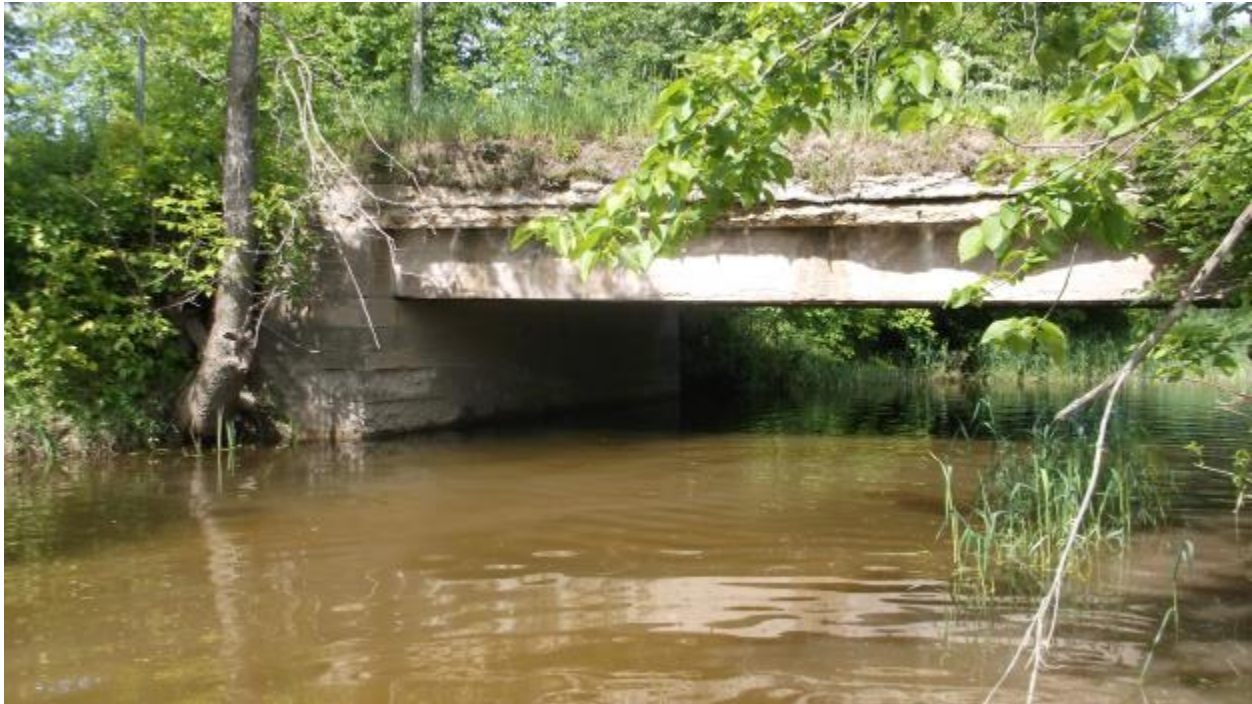
1.27 Bridge No. 35

Bridge 35 is generally in fair condition but is demonstrating signs of localized concrete deterioration on many elements, especially on the exterior fascia and curb face, which has severe cracking, disintegration and separation. Based on the current BCI of 60.8, a minor rehabilitation should be considered as the BCI approaches 60 to ensure the structure does not deteriorate beyond repair. Concrete repairs, curb replacement, waterproofing and paving, and retaining wall installation should be included in the rehabilitation project within the next year. However, given the narrow, sub-standard driving platform width, consideration should be given to forgoing the rehabilitation and scheduling the replacement of the structure within 10 years at a price of approximately \$600,000. Consideration should also be given to installing a barrier on the structure and steel beam guide rail system and end treatments to help protect oncoming traffic.

Maintenance Need	Element and Comments	Estimated Cost
Bridge Cleaning	Clean Streams and Waterways	\$1,000.00
Erosion Control	Repair washouts	\$1,000.00
Total		\$2,000.00

Element	Rehabilitation Required	Priority	Estimated Cost
Type B concrete repairs to Girders, soffit		Within 1 year	\$25,000.00
Type C concrete repairs to abutment walls, ballast walls, wingwalls		Within 1 year	\$30,000.00
Waterproof and Pave		Within 1 year	\$25,000.00
Install retaining walls		Within 1 year	\$30,000.00
Replace curbs and install barrier system		Within 1 year	\$40,000.00
General Items - Insurance, Mobilization, Access etc.		Within 1 year	\$65,000.00
Traffic Control		Within 1 year	\$15,000.00
Other	Engineering Fees (Assumed as ~15% of total costs)	Within 1 year	\$42,000.00
Total			\$272,000.00
