BURNSIDE

2017 Municipal Bridge Inspection Report

**Township of Severn
1024 Hurlwood Lane
P.O. Box 159
Orillia ON L3V 6J3**

**October 18, 2017
300040644.0000**

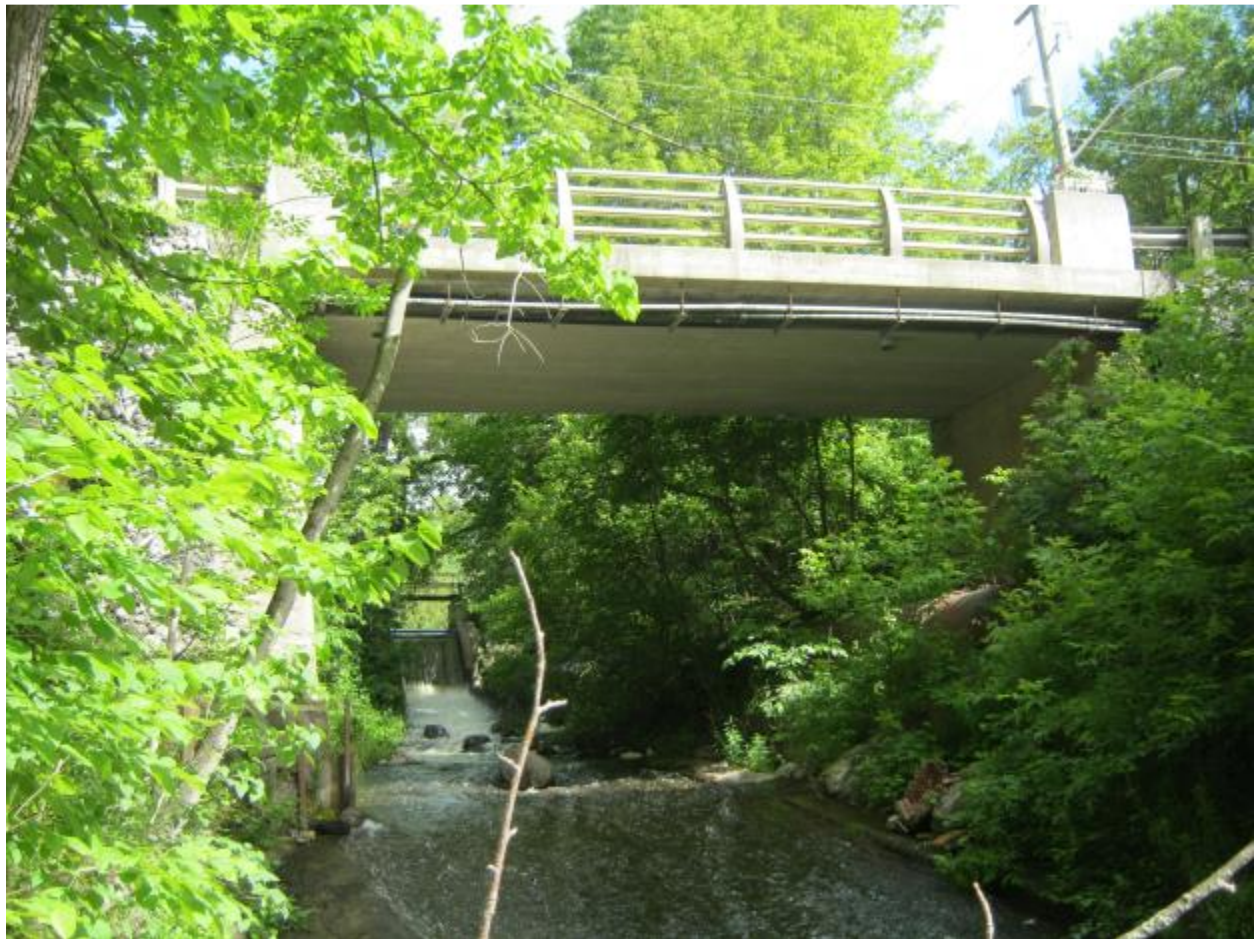
1.28 Bridge No. 36 (Marchmont Mill Bridge)

Bridge 36 is generally in good condition but is demonstrating signs of localized concrete deficiencies and deteriorating asphalt. Based on the current BCI of 73.2, a minor rehabilitation should be considered as the BCI approaches 60 to ensure the structure does not deteriorate beyond repair. Concrete repairs, waterproofing and paving, barrier replacement should be included in the rehabilitation project within approximately 7 years. However, given the narrow, sub-standard driving platform width, consideration should be given to forgoing the rehabilitation and scheduling the replacement of the structure within 17 years at a price of \$1,500,000.

Maintenance Need	Element and Comments	Estimated Cost
Bridge Cleaning	Clean Approach Wearing Surface, Deck Wearing Surface, Seals / Sealants	\$1,500.00
Total		\$1,500.00

Element	Rehabilitation Required	Priority	Estimated Cost
Type A concrete repairs to deck top		6 to 10 years	\$2,500.00
Type C concrete repairs to wingwalls		6 to 10 years	\$20,000.00
Waterproof and Pave		6 to 10 years	\$25,000.00
General Items - Insurance, Mobilization, Access etc.		6 to 10 years	\$65,000.00
Replace Expansion Joints		6 to 10 years	\$60,000.00
Traffic Control		6 to 10 years	\$15,000.00
Other	Engineering Fees (Assumed as ~15% of total costs)	6 to 10 years	\$20,000.00
Total			\$207,500.00

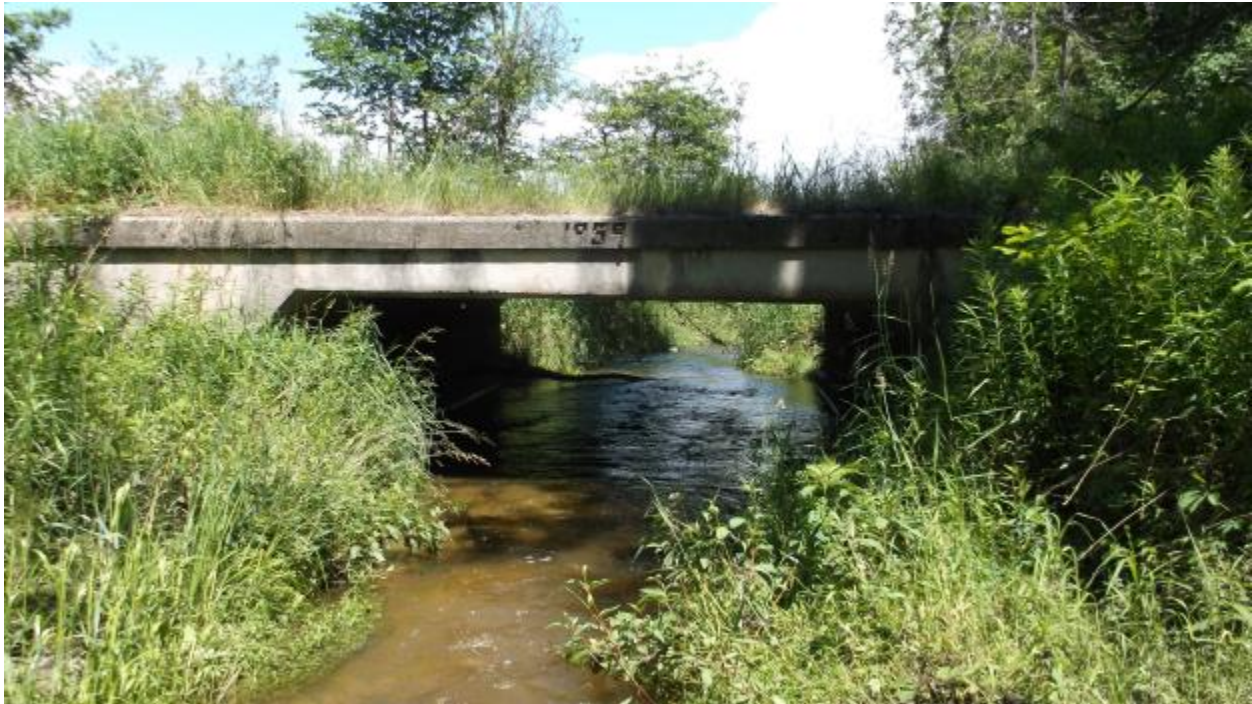
1.29 Bridge No. 39

Bridge 39 is generally in good condition with no major deficiencies needing repair. Based on the current BCI of 73.6 and the span of 5.6m (less than 6m), a rehabilitation is not recommended and replacement of the structure is recommended once the BCI reaches 40, in approximately 17 years at a cost of \$450,000. Consideration should also be given to installing a steel beam guide rail system with a long span treatment spanning over the culvert and end treatments to help protect oncoming traffic.

Maintenance Need	Element and Comments	Estimated Cost
Bridge Cleaning	Clean Vegetation off curbs	\$1,000.00
Bridge Cleaning	Remove debris from watercourse	\$1,000.00
Total		\$2,000.00

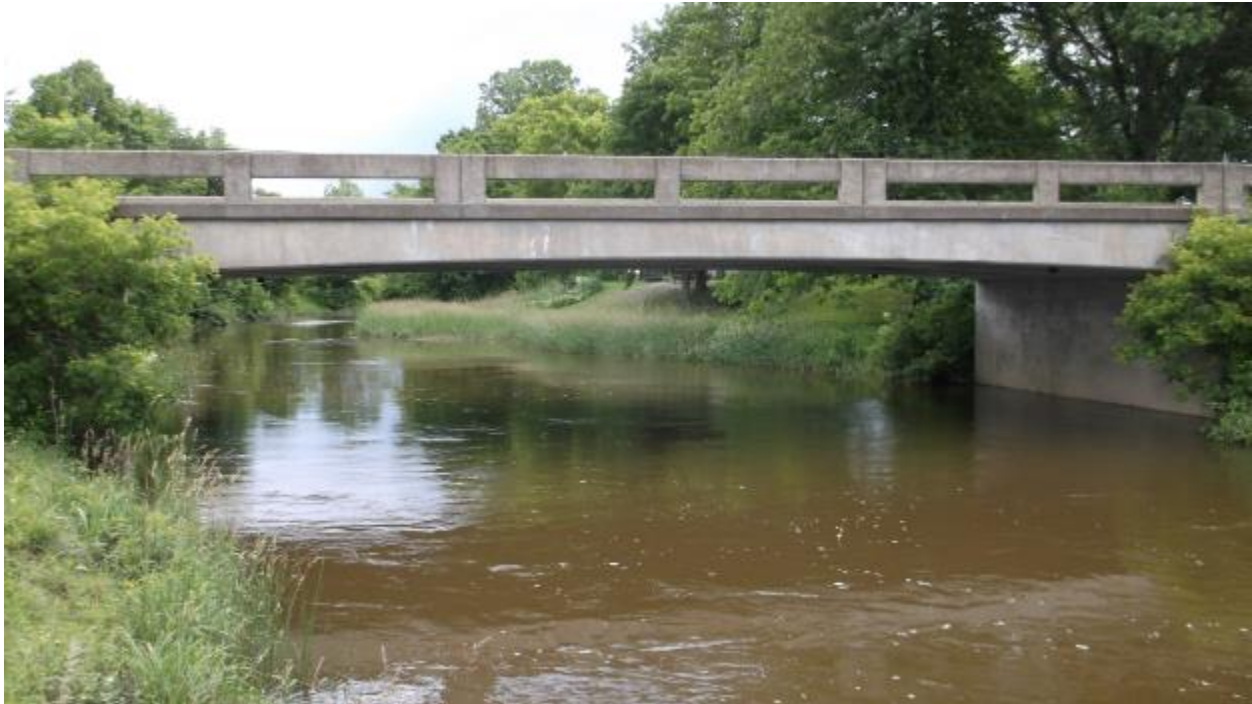
1.30 Bridge No. 40 (North River Bridge)

Bridge 40 is generally in good condition but is demonstrating signs of localized concrete defects. Based on the current BCI of 71.3, a minor rehabilitation should be considered as the BCI approaches 60. Concrete repairs, waterproofing and paving should be included in the rehabilitation project within approximately 6 years. Consideration should also be given to replacing the steel beam guide rail system, end treatments and structure connections as the current end treatments are substandard, there is no connection to the structure and the length of guiderail appears to be inadequate.

Maintenance Need	Element and Comments	Estimated Cost
Deck Drainage	Flush Deck drains	\$1,000.00
Bridge Cleaning	Clean Deck Top	\$1,000.00
Total		\$2,000.00

Element	Rehabilitation Required	Priority	Estimated Cost
Type A concrete repairs to deck top, curbs		6 to 10 years	\$30,000.00
Type B concrete repairs to soffit		6 to 10 years	\$20,000.00
Waterproof and Pave		6 to 10 years	\$50,000.00
General Items - Insurance, Mobilization, Access etc.		6 to 10 years	\$65,000.00
Replace Barriers		6 to 10 years	\$70,000.00
Traffic Control		6 to 10 years	\$15,000.00
Other	Engineering Fees (Assumed as ~15% of total costs)	6 to 10 years	\$46,000.00
Total			\$296,000.00

Element	Work Required	Priority	Estimated Cost
Approaches	Replace Guide Rail, end treatments and structure connections	1 to 5 years	\$52,000.00
Total			\$52,000.00

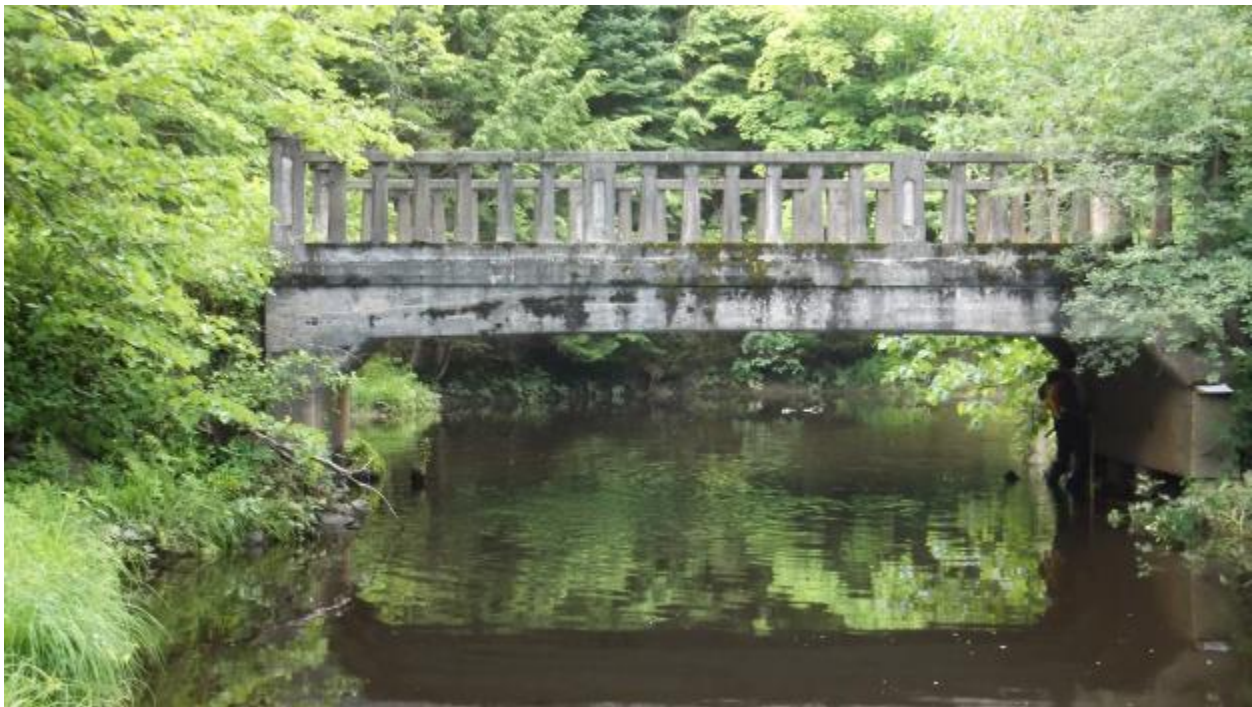
1.31 Bridge No. 41

Bridge 41 is located on an un-named, no winter maintenance road and is generally in good condition but is demonstrating signs of localized minor concrete deficiencies and undermining of the abutment walls that may allow backfill material to wash out from behind the abutments. Based on the current BCI of 73.2, a minor rehabilitation should be considered as the BCI approaches 60 to ensure the structure does not deteriorate beyond repair. Localized concrete repairs and erosion protection installation should be included in the rehabilitation project within approximately 7 years. However, given the location of the structure and that it appears to service only one property (farm land), the Township should consider forgoing the rehabilitation, acquiring property and closing the structure when the condition decreases to the point of requiring replacement, which is estimated to be in approximately 17 years.

Maintenance Need	Element and Comments	Estimated Cost
Bridge Cleaning	Clean Deck Top	\$1,000.00
Erosion Control	Install erosion protection	\$3,000.00
Total		\$4,000.00

Element	Rehabilitation Required	Priority	Estimated Cost
Type B concrete repairs to Girders, soffit		6 to 10 years	\$3,000.00
Type C concrete repairs to abutment walls		6 to 10 years	\$1,500.00
General Items - Insurance, Mobilization, Access etc.		6 to 10 years	\$65,000.00
Other	Engineering Fees (Assumed as ~15% of total costs)	6 to 10 years	\$10,000.00
Total			\$79,500.00

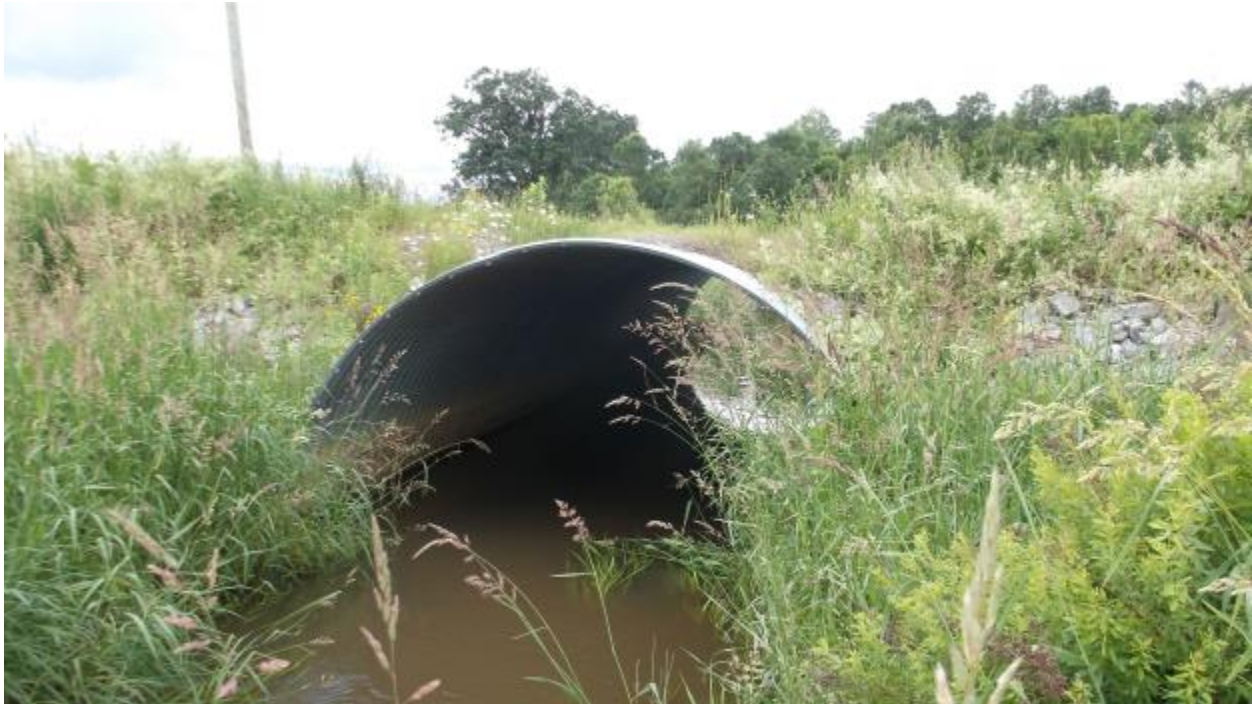
1.34 Culvert No. 20

Culvert 20 is generally in good condition with no major deficiencies needing repair at this time. Based on the current BCI of 74.8 and the span of 3.8m (less than 6m), a rehabilitation is not recommended and replacement of the structure is recommended once the BCI reaches 40, in approximately 18 years at a cost of approximately \$400,000. Consideration should be given to completing the recommended maintenance work and investigating the need for guide rail, as the clear zone on the east does not appear to be sufficient.

Maintenance Need	Element and Comments	Estimated Cost
Rout and Seal	Repairs required to Approach Wearing Surface	\$500.00
Hazard Signs	Install hazard warning signs at structure	\$1,000.00
Total		\$1,500.00

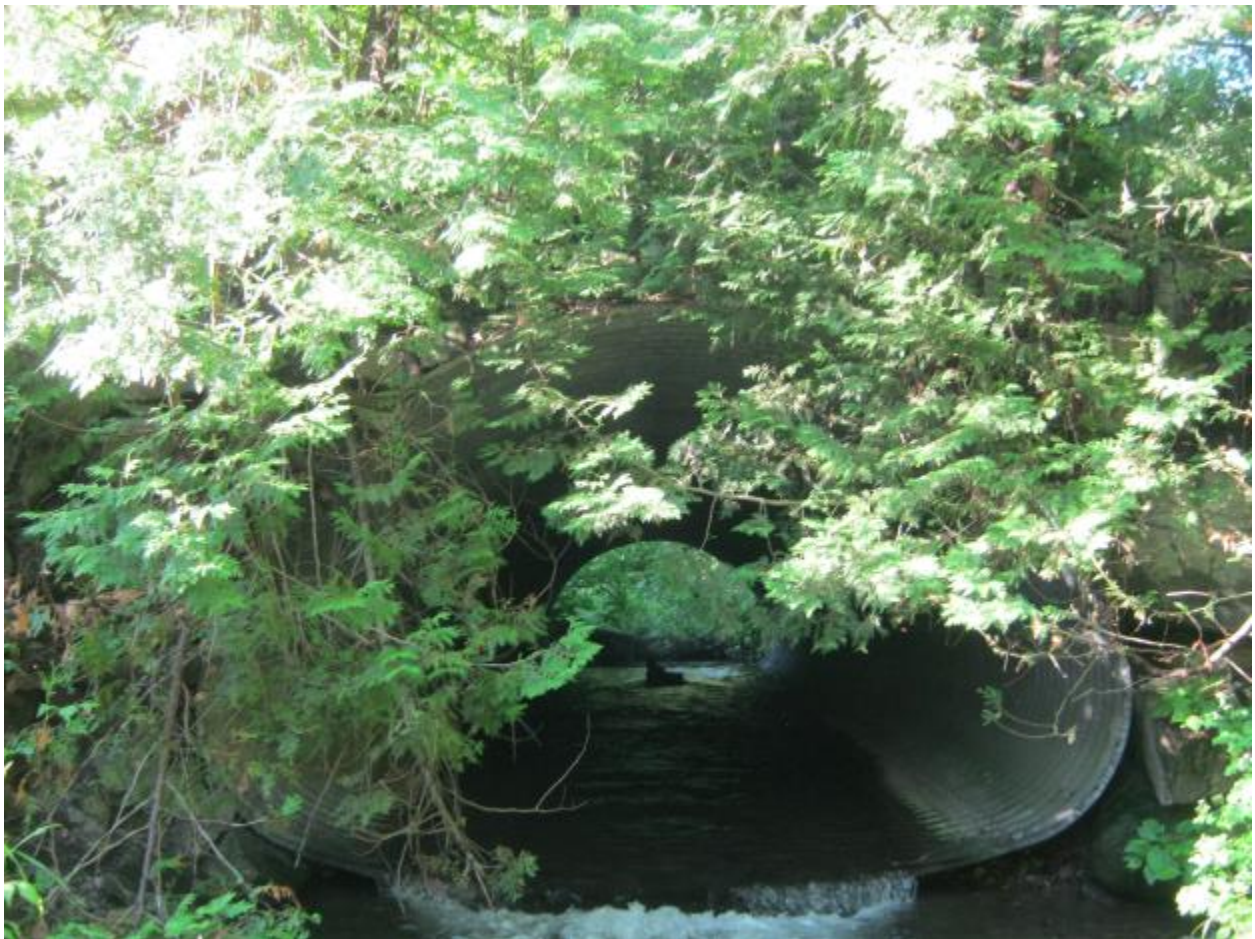
1.35 Culvert No. 30

Culvert 30 is generally in good to fair condition but is demonstrating signs of erosion at the embankments and failing rock retaining walls. Based on the current BCI of 67.6, the span of 4.4m (less than 6m), and the structure type a rehabilitation is not recommended and replacement of the structure is recommended once the BCI reaches 40, in approximately 14 years at a cost of approximately \$450,000. However, the Township should consider replacing the retaining wall as soon as possible to help prevent further failure of embankments.

Maintenance Need	Element and Comments	Estimated Cost
Bridge Cleaning	Remove built up debris from watercourse	\$1,000.00
Erosion Control	Repair washouts at guiderail posts and erosion of embankment	\$6,000.00
Retaining Wall	Replace retaining wall	\$40,000.00
Total		\$47,000.00
